General Information

Make	Toyota	Model	Vios
YOM	2026	Odo Meter Reading	1,888
Registration No.	CCQ4945	Chassis No.	PA1B118F39S4297114
CC	1.3	Transmission	CVT
Fuel Type	Gas	Type of Body	Sedan
Colour	Silver

Body / Panel Condition

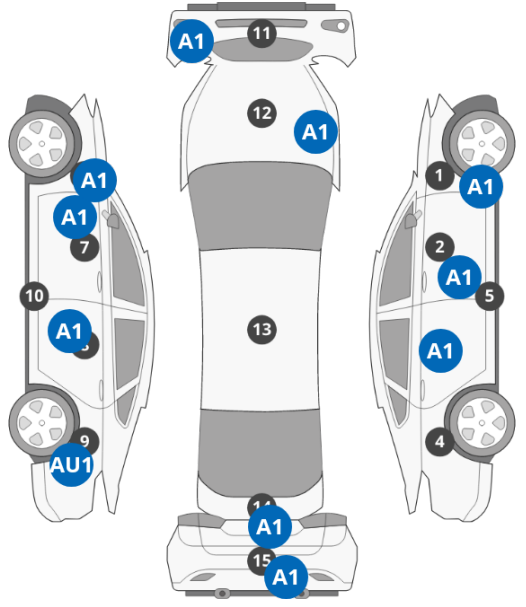
<p>A : Scratch AU : Scratch & Dent B : Modified C : Corrosion G : Stone chip P : Faded S : Rust SC : Rust & Corrosion U : Dent X : Defective Y : Crack, Gap</p>
Remarks Defects not found	Remarks (R) Front Fender, Molding - Scratch - Minimal / (R) Front Door, Molding - Scratch - Minimal / (R) Rear Door, Molding - Scratch - Minimal / Trunk Hood, Rear Gate - Scratch - Minimal / Rear Bumper, Lamps, Panels - Scratch - Minimal / (L) Rear Fender, Molding - Scratch & Dent - Minimal / (L) Rear Door, Molding - Scratch - Minimal / (L) Front Door, Molding - Scratch - Minimal / (L) Front Fender, Molding - Scratch - Minimal / Bonnet, Headlight - Scratch - Minimal / Front Bumper, Grille, Lamps - Scratch - Minimal
Frame Evaluation : A	Functional Evaluation : A

Inspector Notes
With Lto plate ,with warranty booklet,3keys, no spare tire, no jack and tools ,scratches on headlights
