General Information

Date & Time: 26, Jan, 2026 16:32

Make	Toyota	Model	Wigo
YOM	2025	Odo Meter Reading	13,727
Registration No.	DBT4219	Chassis No.	MHKAA1BC3RJ34252
CC	1.0	Transmission	CVT
Fuel Type	Gas	Type of Body	Hatchback
Colour	Orange

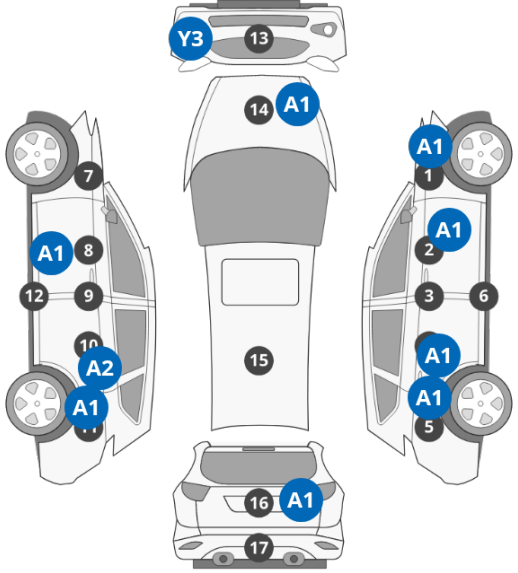
<p>A : Scratch AU : Scratch & Dent B : Modified C : Corrosion G : Stone chip P : Faded S : Rust SC : Rust & Corrosion U : Dent X : Defective Y : Crack, Gap</p>
Remarks Defects not found	Remarks (R) Front Fender, Molding - Scratch - Minimal / (R) Front Door, Molding - Scratch - Minimal / (R) Rear Door, Molding - Scratch - Minimal / (R) Rear Fender, Molding - Scratch - Minimal / Trunk Hood, Rear Gate - Scratch - Minimal / (L) Rear Fender, Molding - Scratch - Minimal / (L) Rear Door, Molding - Scratch - Small / (L) Front Door, Molding - Scratch - Minimal / Bonnet, Headlight - Scratch - Minimal / Front Bumper, Grille, Lamps - Crack, Gap - Medium
Frame Evaluation : A	Functional Evaluation : A
Remarks Defects not found	Remarks Defects not found
