General Information

Make	Toyota	Model	Lite Ace
YOM	2023	Odo Meter Reading	34,940
Registration No.	FAO5992	Chassis No.	MHKU3FE10PK003764
CC	1.5	Transmission	M/T
Fuel Type	Gas	Type of Body	Utility Passenger
Colour	White

Body / Panel Condition

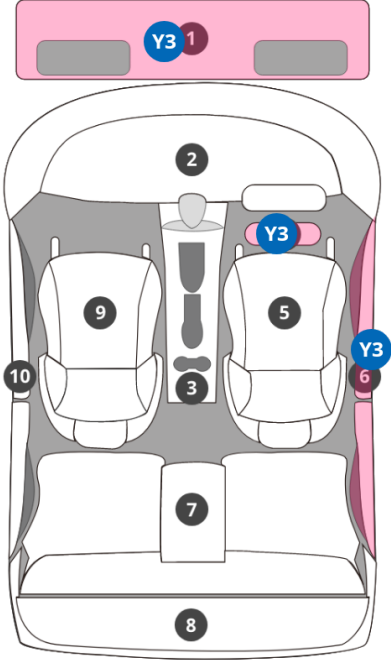
<p>a : Cut, Fray d : Loose, Deformed k : Animal Hair s : Smell t : Cigarette Burns x : Defective y : Stain</p>

<p>A : Scratch AU : Scratch & Dent B : Modified C : Corrosion G : Stone chip P : Faded S : Rust SC : Rust & Corrosion U : Dent X : Defective Y : Crack, Gap</p>
<p>Remarks (R) Front Trim - Grime - Medium / Ceiling - Grime - Medium / (L) Front Floor Mat - Grime - Medium</p>	<p>Remarks (R) Side Gate - Rust, Corrosion - Medium / Rear Bumper, Lamps, Panels - Scratch - Medium / Rear Gate - Rust, Corrosion - Medium / (L) Side Gate - Repair mark - Difference in Color / (L) Rear Door, Molding - Scratch - Small / (L) Front Fender, Molding - Scratch - Small / Front Panel - Scratch - Small</p>
Frame Evaluation : A	Functional Evaluation : B
<p>Remarks Defects not found</p>	<p>Remarks Battery - Weak - Yes / Head Light, High Beam - Issue - Yes</p>

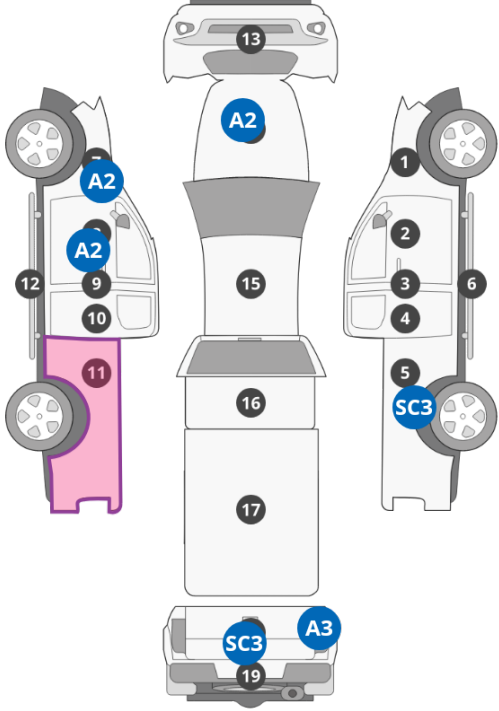
<p>Inspector Notes</p>
<p>Busted Left Break light. With 2 spare key. with spare tire. no jack and tools. with warranty booklet. no seat cover</p>
