General Information

Make	Toyota	Model	Vios
YOM	2024	Odo Meter Reading	24,456
Registration No.	CAZ6490	Chassis No.	PA1B18F31P4228991
CC	1.3	Transmission	CVT
Fuel Type	Gas	Type of Body	Sedan
Colour	Black

Body / Panel Condition

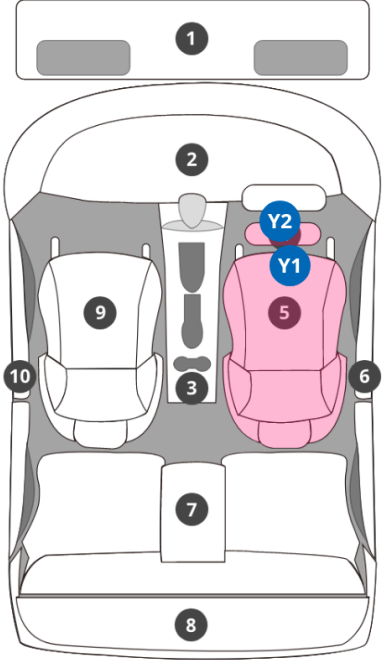
<p>a : Cut, Fray d : Loose, Deformed k : Animal Hair s : Smell t : Cigarette Burns x : Defective y : Stain</p>

<p>A : Scratch AU : Scratch & Dent B : Modified C : Corrosion G : Stone chip P : Faded S : Rust SC : Rust & Corrosion U : Dent X : Defective Y : Crack, Gap</p>
<p>Remarks (L) Front Floor Mat - Grime - Small / (R) Front Seat - Grime - Minimal</p>	<p>Remarks (R) Front Fender, Molding - Scratch - Small / (R) Mirror - Scratch - Minimal / (R) Front Door, Molding - Scratch - Minimal / (R) Step, In-panel, Side Spoiler - Scratch & Dent - Minimal / (R) Rear Fender, Molding - Scratch - Minimal / Rear Bumper, Lamps, Panels - Scratch - Medium / Trunk Hood, Rear Gate - Scratch - Minimal / (L) Rear Fender, Molding - Scratch - Minimal / (L) Rear Door, Molding - Scratch - Small / (L) Front Door, Molding - Scratch & Dent - Minimal / (L) Step, In-panel, Side Spoiler - Scratch - Medium / (L) Front Fender, Molding - Scratch - Medium / Bonnet, Headlight - Scratch & Dent - Minimal / Front Bumper, Grille, Lamps - Scratch - Medium</p>

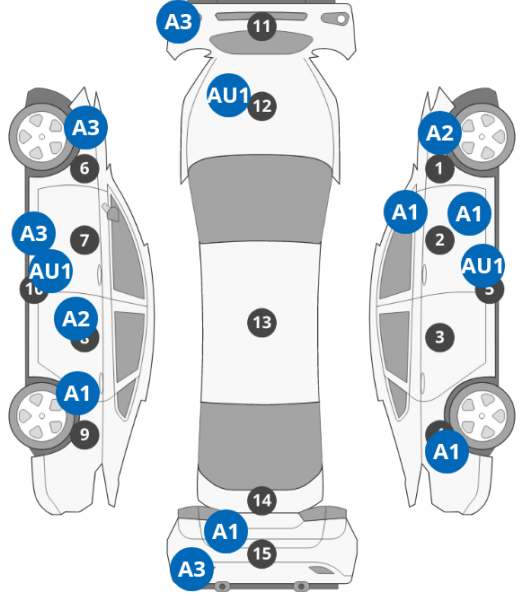
<p>Inspector Notes</p>
<p>With Lto plate, with warranty booklet, with jack and tools, 1key, no spare tire, scratches on headlights and taillights</p>
