General Information

| Make | Toyota | Model | Wigo |

Body / Panel Condition

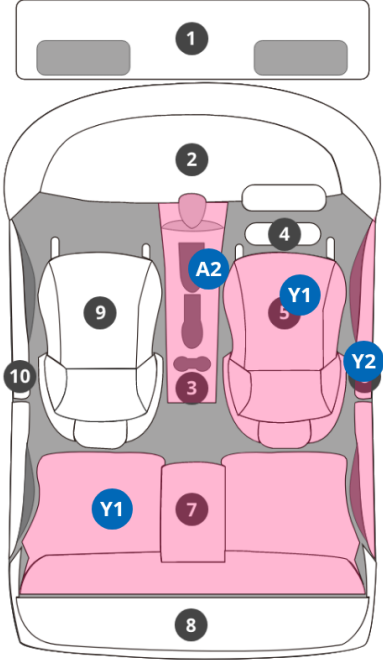
| Interior Evaluation : A | Exterior Evaluation : B |
| <p>Remarks (R) Front Seat - Grime - Minimal / Knobs - Worn, Peel, Crack - Small / (R) Front Trim - Grime - Small / Rear Seat - Grime - Minimal</p> | <p>Remarks Trunk Hood, Rear Gate - Repair Traces - Yes / (R) Front Door, Molding - Scratch - Medium / (L) Front Door, Molding - Scratch - Small / Trunk Hood, Rear Gate - Scratch - Minimal / Front Bumper, Grille, Lamps - Scratch - Small</p> |
