General Information

Make	Toyota	Model	Hilux
YOM	2024	Odo Meter Reading	26,080
Registration No.	GBE5178	Chassis No.	MR0JB8DD4R3229174
CC	2.4	Transmission	A/T
Fuel Type	Diesel	Type of Body	Pickup
Colour	Gray

Body / Panel Condition

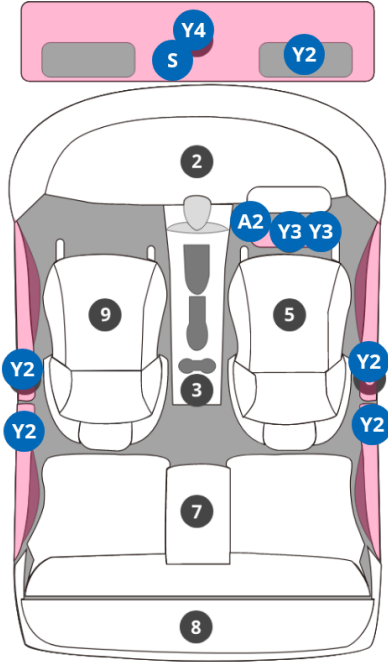
Interior Evaluation : C	Exterior Evaluation : E

<p>a : Cut, Fray d : Loose, Deformed k : Animal Hair s : Smell t : Cigarette Burns x : Defective y : Stain</p>

<p>Inspector Notes</p>
<p>Replace fuel filter indicated at the instrument panel. Rusted seat railings. Bad smell. Rear window automatic switch issue both sides. Master switch for rear windows not working. Without warranty booklet, jack and tools. With spare tire and seat cover. 1 key. With LTO plate.</p>

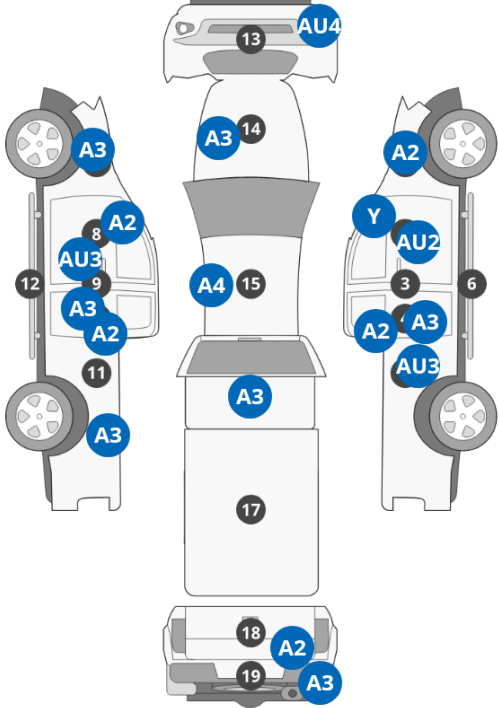
<p>A : Scratch AU : Scratch & Dent B : Modified C : Corrosion G : Stone chip P : Faded S : Rust SC : Rust & Corrosion U : Dent X : Defective Y : Crack, Gap</p>
<p>Remarks (L) Front Floor Mat - Cut, Crack - Small / (L) Front Trim - Grime - Small / Ceiling - Grime - Large / Sunvisor, Sunglass Holder - Grime - Small / (L) Rear Trim - Grime - Small / Mat Other - Grime - Medium / (R) Rear Trim - Grime - Small / (R) Front Trim - Grime - Small / (R) Front Floor Mat - Grime - Medium / Overall Interior - Smell - Yes</p>	<p>Remarks Front Bumper, Grille, Lamps - Scratch & Dent - Large / (R) Front Fender, Molding - Scratch - Small / (R) Front Door, Molding - Scratch & Dent - Small / (R) Rear Door, Molding - Scratch - Medium / (R) Rear Corner Panel - Scratch - Small / (R) Side Gate - Scratch & Dent - Medium / Rear Gate - Scratch - Small / Rear Bumper, Lamps, Panels - Scratch - Medium / (L) Side Gate - Scratch - Medium / (L) Rear Corner Panel - Scratch - Small / (L) Rear Door, Molding - Scratch - Medium / (L) Front Door, Molding - Scratch & Dent - Medium / (L) Mirror - Scratch - Small / (L) Front Fender, Molding - Scratch - Medium / Roof - Scratch - Large / Cab Back Panel - Scratch - Medium / Bonnet, Headlight - Scratch - Medium / (R) Mirror - Crack - Cracks</p>
