General Information

Make	Toyota	Model	Vios
YOM	2025	Odo Meter Reading	18,998
Registration No.	GBF2874	Chassis No.	PA1B18F32R4266538
CC	1.3	Transmission	CVT
Fuel Type	Gas	Type of Body	Sedan
Colour	Blackish Red Mica

Body / Panel Condition

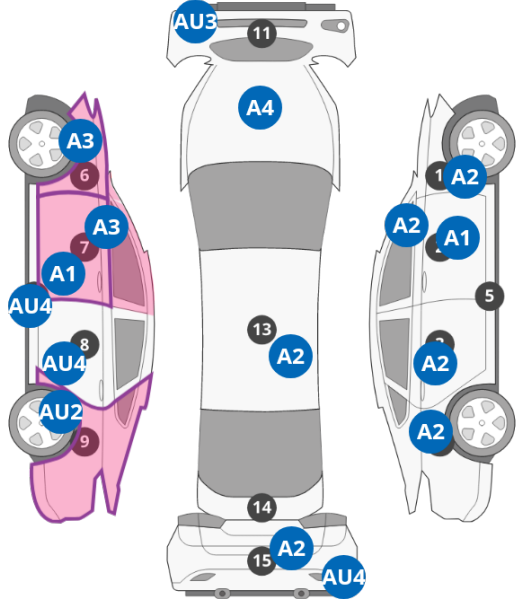
<p>A : Scratch AU : Scratch & Dent B : Modified C : Corrosion G : Stone chip P : Faded S : Rust SC : Rust & Corrosion U : Dent X : Defective Y : Crack, Gap</p>
<p>Remarks (R) Front Trim - Grime - Small / (R) Front Floor Mat - Missing - Yes / Mat Other - Missing - Yes / (L) Front Floor Mat - Missing - Yes / (L) Front Trim - Grime - Small / Ceiling - Grime - Small</p>	<p>Remarks (L) Front Fender - Repair Traces - Yes / (L) Front Door - Repair Traces - Yes / (L) Step - Repair Traces - Yes / (L) Rear Fender - Repair Traces - Yes / (L) Front Fender, Molding - Repair mark - Yes / (L) Front Door, Molding - Repair mark - Yes / (L) Rear Fender, Molding - Repair mark - Yes / (L) Front Fender, Molding - Scratch - Medium / (L) Mirror - Scratch - Medium / (L) Front Door, Molding - Scratch - Minimal / (L) Rear Door, Molding - Scratch & Dent - Large / (L) Step, In-panel, Side Spoiler - Scratch & Dent - Large / (L) Rear Fender, Molding - Scratch & Dent - Small / Trunk Hood, Rear Gate - Scratch - Small / Rear Bumper, Lamps, Panels - Scratch & Dent - Large / (R) Rear Fender, Molding - Scratch - Small / (R) Rear Door, Molding - Scratch - Small / (R) Mirror - Scratch - Small / (R) Front Door, Molding - Scratch - Minimal / (R) Front Fender, Molding - Scratch - Small / Bonnet, Headlight - Scratch - Large / Front Bumper, Grille, Lamps - Scratch & Dent - Medium / Roof - Scratch - Small</p>
