General Information

Make	Toyota	Model	Vios
YOM	2025	Odo Meter Reading	10,395
Registration No.	GBK8001	Chassis No.	PA1B18F35S4292993
CC	1.3	Transmission	CVT
Fuel Type	Gas	Type of Body	Sedan
Colour	Silver

Body / Panel Condition

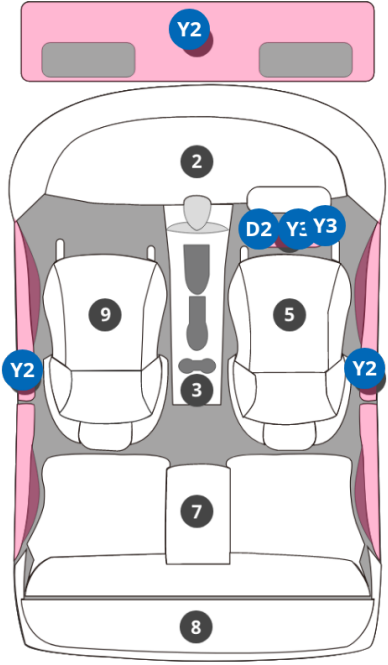
Interior Evaluation : B	Exterior Evaluation : C

<p>a : Cut, Fray d : Loose, Deformed k : Animal Hair s : Smell t : Cigarette Burns x : Defective y : Stain</p>

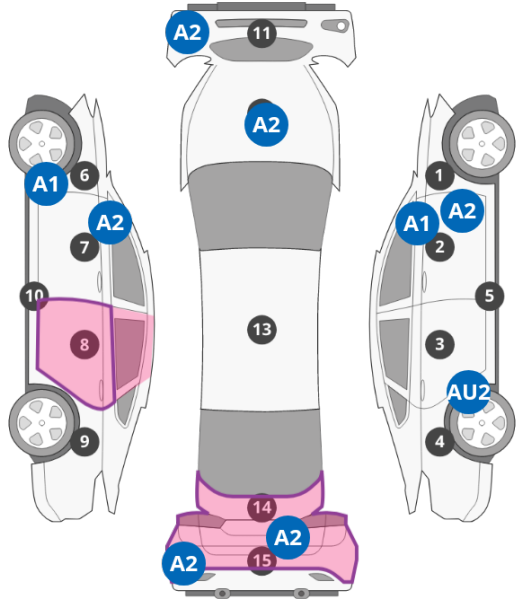
<p>A : Scratch AU : Scratch & Dent B : Modified C : Corrosion G : Stone chip P : Faded S : Rust SC : Rust & Corrosion U : Dent X : Defective Y : Crack, Gap</p>
<p>Remarks (L) Front Trim - Grime - Small / (L) Front Floor Mat - Worked - Small / Ceiling - Grime - Small / Mat Other - Grime - Medium / (R) Front Floor Mat - Grime - Medium / (R) Front Trim - Grime - Small</p>	<p>Remarks Trunk Hood, Rear Gate - Repair Traces - Yes / (L) Mirror - Scratch - Small / (L) Front Fender, Molding - Scratch - Minimal / (L) Rear Door, Molding - Repair mark - Yes / Trunk Hood, Rear Gate - Repair mark - Yes / Trunk Hood, Rear Gate - Scratch - Small / Rear Bumper, Lamps, Panels - Scratch - Small / (R) Rear Fender, Molding - Scratch & Dent - Small / (R) Mirror - Scratch - Minimal / (R) Front Door, Molding - Scratch - Small / Bonnet, Headlight - Scratch - Small / Front Bumper, Grille, Lamps - Scratch - Small</p>
