## General Information

| <b>Make</b> | Toyota | <b>Model</b> | Vios |
| <b>Registration No.</b> | GBB3381 | <b>Chassis No.</b> | PA1B18F39S4289109 |

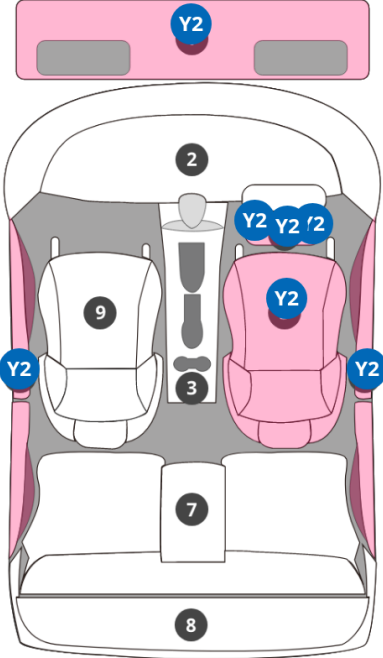
| <b>Interior Evaluation :</b> <span style="float: right;"><b>B</b></span> | <b>Exterior Evaluation :</b> <span style="float: right;"><b>E</b></span> |

| <p><b>Remarks</b><br/>(L) Front Floor Mat - Grime - Small / (L) Front Trim - Grime - Small / Ceiling - Grime - Small / (R) Front Trim - Grime - Small / (R) Front Floor Mat - Grime - Small / Mat Other - Grime - Small / (R) Front Seat - Grime - Small</p> | <p><b>Remarks</b><br/>(L) Front Fender, Molding - Scratch &amp; Dent - Minimal / (L) Mirror - Scratch - Small / (L) Front Door, Molding - Scratch - Medium / (L) Step, In-panel, Side Spoiler - Scratch - Minimal / (L) Rear Door, Molding - Scratch - Large / (L) Rear Fender, Molding - Scratch - Medium / Rear Bumper, Lamps, Panels - Scratch - Medium / Trunk Hood, Rear Gate - Scratch - Medium / (R) Rear Fender, Molding - Scratch - Large / (R) Rear Door, Molding - Scratch - Large / (R) Step, In-panel, Side Spoiler - Scratch - Small / (R) Front Door, Molding - Scratch - Large / (R) Mirror - Scratch - Small / (R) Front Fender, Molding - Scratch - Medium / Bonnet, Headlight - Scratch - Large / Front Bumper, Grille, Lamps - Scratch - Small / Roof - Scratch - Medium / (L) Front Wheel, Cover - Cap Missing - Yes / (L) Rear Wheel, Cover - Cap Missing - Yes / (R) Rear Wheel, Cover - Cap Missing - Yes / (R) Front Wheel, Cover - Cap Missing - Yes</p> |

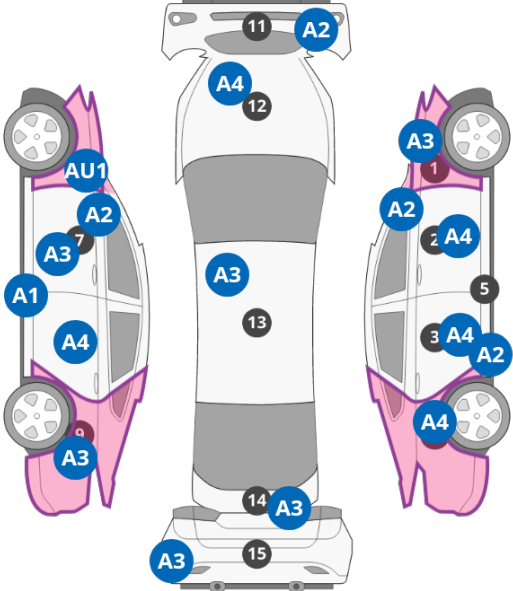
| <p>Vios older model mags installed in this unit. Scratches on front windshield. With warranty booklet, spare tire, jack and seat cover. 1 key. With LTO plate.</p> |
