General Information

Make	Toyota	Model	Wigo
YOM	2025	Odo Meter Reading	8,920
Registration No.	GBK7726	Chassis No.	MHKAA1BC9SJ042569
CC	1.0	Transmission	CVT
Fuel Type	Gas	Type of Body	Hatchback
Colour	Orange

Body / Panel Condition

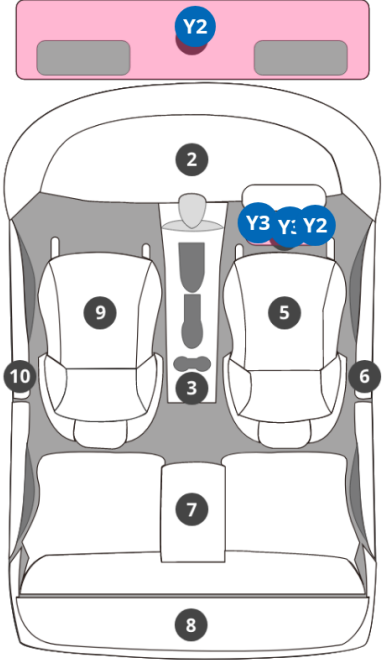
Interior Evaluation : B	Exterior Evaluation : E

<p>a : Cut, Fray d : Loose, Deformed k : Animal Hair s : Smell t : Cigarette Burns x : Defective y : Stain</p>

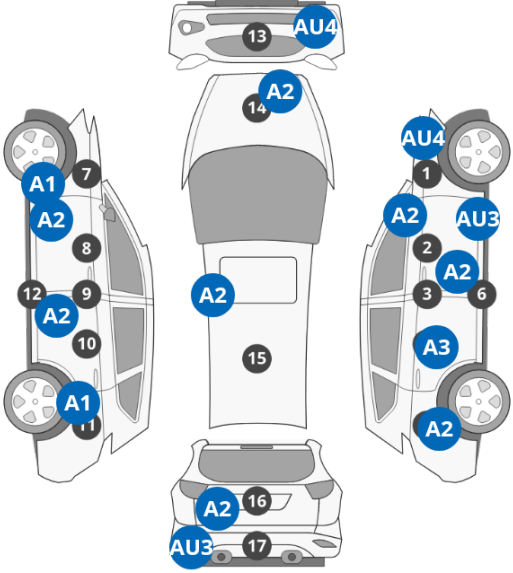
<p>A : Scratch AU : Scratch & Dent B : Modified C : Corrosion G : Stone chip P : Faded S : Rust SC : Rust & Corrosion U : Dent X : Defective Y : Crack, Gap</p>
<p>Remarks (L) Front Floor Mat - Grime - Medium / Ceiling - Grime - Small / Mat Other - Grime - Medium / (R) Front Floor Mat - Grime - Small</p>	<p>Remarks Bonnet, Headlight - Scratch - Small / (L) Rear Door, Molding - Scratch - Small / (L) Front Door, Molding - Scratch - Small / (L) Front Fender, Molding - Scratch - Minimal / (L) Rear Fender, Molding - Scratch - Minimal / Trunk Hood, Rear Gate - Scratch - Small / Rear Bumper, Lamps, Panels - Scratch & Dent - Medium / (R) Rear Door, Molding - Scratch - Medium / (R) Rear Fender, Molding - Scratch - Small / (R) Mirror - Scratch - Small / (R) Front Fender, Molding - Scratch & Dent - Large / (R) Step, In-panel, Side Spoiler - Scratch & Dent - Medium / (R) Front Door, Molding - Scratch - Small / Front Bumper, Grille, Lamps - Scratch & Dent - Large / Roof - Scratch - Small</p>
