General Information

Make	Toyota	Model	Wigo
YOM	2025	Odo Meter Reading	4,586
Registration No.	GBJ6681	Chassis No.	MHKAA1BC7RJ034044
CC	1.0	Transmission	CVT
Fuel Type	Gas	Type of Body	Hatchback
Colour	Orange

Body / Panel Condition

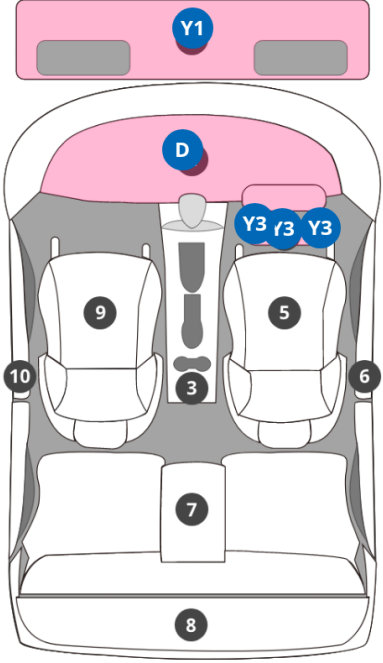
Interior Evaluation : B	Exterior Evaluation : C

<p>a : Cut, Fray d : Loose, Deformed k : Animal Hair s : Smell t : Cigarette Burns x : Defective y : Stain</p>

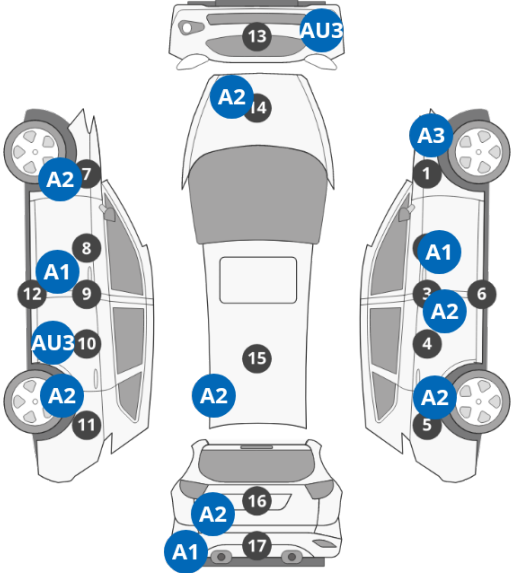
<p>A : Scratch AU : Scratch & Dent B : Modified C : Corrosion G : Stone chip P : Faded S : Rust SC : Rust & Corrosion U : Dent X : Defective Y : Crack, Gap</p>
<p>Remarks (R) Front Floor Mat - Grime - Medium / Dashboard - Traces of Adhesive Tape - Yes / Mat Other - Grime - Medium / Ceiling - Grime - Minimal / (L) Front Floor Mat - Grime - Medium</p>	<p>Remarks (L) Front Fender, Molding - Scratch - Small / (L) Rear Door, Molding - Scratch & Dent - Medium / (L) Front Door, Molding - Scratch - Minimal / (L) Rear Fender, Molding - Scratch - Small / (R) Rear Fender, Molding - Scratch - Small / (R) Rear Door, Molding - Scratch - Small / (R) Front Door, Molding - Scratch - Minimal / (R) Front Fender, Molding - Scratch - Medium / Bonnet, Headlight - Scratch - Small / Front Bumper, Grille, Lamps - Scratch & Dent - Medium / Roof - Scratch - Small / Rear Bumper, Lamps, Panels - Scratch - Minimal / Trunk Hood, Rear Gate - Scratch - Small</p>
