General Information

Make	Toyota	Model	Vios
YOM	2025	Odo Meter Reading	16,632
Registration No.	GBJ1162	Chassis No.	PA1B18F31R4277319
CC	1.3	Transmission	CVT
Fuel Type	Gas	Type of Body	Sedan
Colour	Red

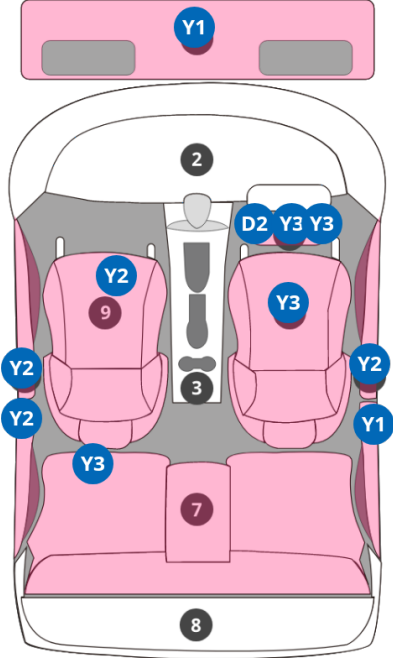
<p>Interior Evaluation : C</p>	<p>Exterior Evaluation : E</p>

<p>a : Cut, Fray d : Loose, Deformed k : Animal Hair s : Smell t : Cigarette Burns x : Defective y : Stain</p>

<p>A : Scratch AU : Scratch & Dent B : Modified C : Corrosion G : Stone chip P : Faded S : Rust SC : Rust & Corrosion U : Dent X : Defective Y : Crack, Gap</p>
<p>Remarks (L) Front Seat - Grime - Small / (L) Front Floor Mat - Worked - Small / (L) Front Trim - Grime - Small / Ceiling - Grime - Minimal / (L) Rear Trim - Grime - Small / Rear Seat - Grime - Medium / Mat Other - Grime - Medium / (R) Rear Trim - Grime - Minimal / (R) Front Trim - Grime - Small / (R) Front Floor Mat - Grime - Medium / (R) Front Seat - Grime - Medium</p>	<p>Remarks Bonnet - Repair Traces - Yes / (L) Front Door - Repair Traces - Yes / (L) Front Fender, Molding - Repair mark - Yes / (L) Front Door, Molding - Repair mark - Yes / Overall Exterior - Re-Paint Uneven - Yes / (L) Mirror - Scratch - Small / (L) Front Door, Molding - Scratch - Small / (L) Rear Door, Molding - Scratch - Small / (L) Rear Fender, Molding - Scratch - Small / Trunk Hood, Rear Gate - Scratch - Medium / Rear Bumper, Lamps, Panels - Scratch & Dent - Medium / (R) Rear Fender, Molding - Scratch - Medium / (R) Rear Door, Molding - Scratch - Medium / (R) Front Door, Molding - Scratch - Small / (R) Step, In-panel, Side Spoiler - Scratch & Dent - Medium / (R) Mirror - Scratch - Small / (R) Front Fender, Molding - Scratch - Small / Bonnet, Headlight - Repair mark - Yes / Front Bumper, Grille, Lamps - Repair mark - Yes / Front Bumper, Grille, Lamps - Scratch & Dent - Medium / Roof - Scratch - Medium</p>

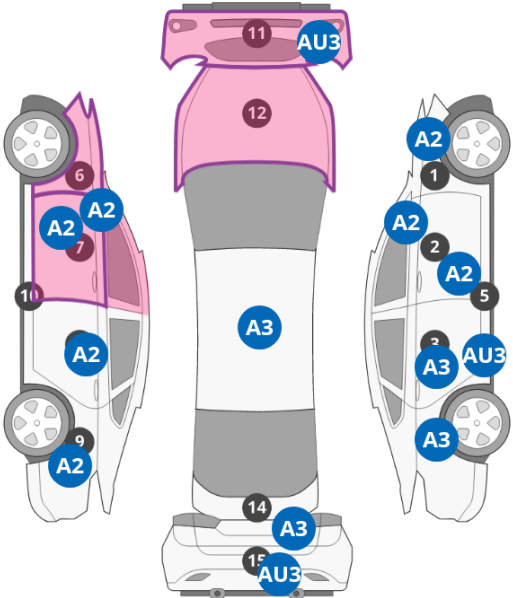
<p>Frame Evaluation : D</p>	<p>Functional Evaluation : A</p>
<p>Remarks Left Front Inside Panel (Front Side) - Traces of Bending, or Marks of Panel Repair ? - Yes / Front Cross Member Support - Traces of Bending, or Marks of Panel Repair ? - Yes / Left Front Pillar - Traces of Bending, or Marks of Panel Repair ? - Yes</p>	<p>Remarks Spare Key - Issue - Unexist</p>

<p>Inspector Notes</p>
<p>Possible flooding. Left front door, left front fender and bonnet repaired. Without warranty booklet, seat cover and jack. Incomplete tools. With spare tire. 1 key. With LTO plate.</p>
