General Information

Make	Suzuki	Model	XL7
YOM	2025	Odo Meter Reading	9,601
Registration No.	GBJ4095	Chassis No.	MHYNC32S6SJ104658
CC	1.5	Transmission	A/T
Fuel Type	Gas	Type of Body	Wagon
Colour	Black

Body / Panel Condition

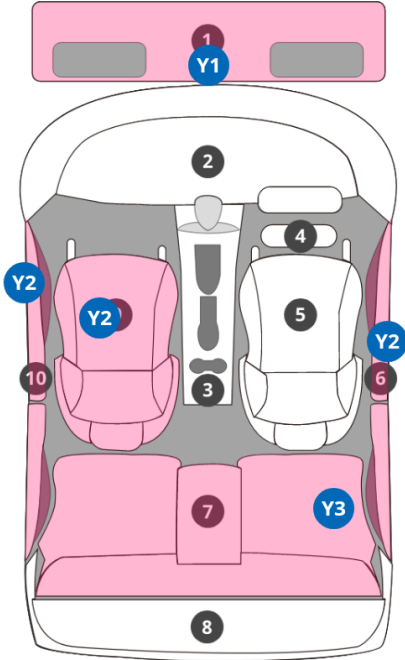
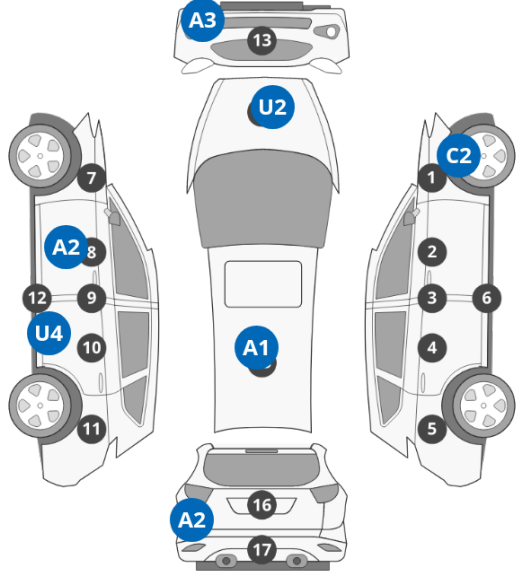
Interior Evaluation :	B	Exterior Evaluation :	C

<p>a : Cut, Fray d : Loose, Deformed k : Animal Hair s : Smell t : Cigarette Burns x : Defective y : Stain</p>		<p>A : Scratch AU : Scratch & Dent B : Modified C : Corrosion G : Stone chip P : Faded S : Rust SC : Rust & Corrosion U : Dent X : Defective Y : Crack, Gap</p>	
<p>Remarks Rear Seat - Grime - Medium / (R) Front Trim - Grime - Small / (L) Front Seat - Grime - Small / (L) Front Trim - Grime - Small / Ceiling - Grime - Minimal</p>		<p>Remarks (R) Front Door - Repair Traces - Yes / Roof - Repair Traces - Yes / (L) Rear Door, Molding - Dent - Large / Front Bumper, Grille, Lamps - Scratch - Medium / Bonnet, Headlight - Dent - Small / (R) Front Wheel, Cover - Scratch, Corrosion - Small / (L) Front Door, Molding - Scratch - Small / Roof - Scratch - Minimal / Trunk Hood, Rear Gate - Scratch - Small</p>	
Frame Evaluation :	A	Functional Evaluation :	A
