## General Information

<b>Make</b>	Toyota	<b>Model</b>	Vios
<b>YOM</b>	2025	<b>Odo Meter Reading</b>	6,531
<b>Registration No.</b>	FAT4653	<b>Chassis No.</b>	PA1B18F3XS4288809
<b>CC</b>	1.3	<b>Transmission</b>	CVT
<b>Fuel Type</b>	Gas	<b>Type of Body</b>	Sedan
<b>Colour</b>	Silver

## Body / Panel Condition

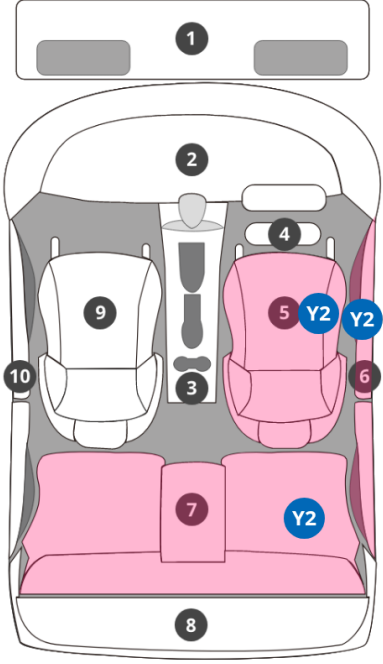
<p><b>a</b> : Cut, Fray <b>d</b> : Loose, Deformed <b>k</b> : Animal Hair <b>s</b> : Smell <b>t</b> : Cigarette Burns <b>x</b> : Defective <b>y</b> : Stain</p>

<p><b>A</b> : Scratch <b>AU</b> : Scratch &amp; Dent <b>B</b> : Modified <b>C</b> : Corrosion <b>G</b> : Stone chip <b>P</b> : Faded <b>S</b> : Rust <b>SC</b> : Rust &amp; Corrosion <b>U</b> : Dent <b>X</b> : Defective <b>Y</b> : Crack, Gap</p>
<p><b>Remarks</b> (R) Front Seat - Grime - Small / Rear Seat - Grime - Small / (R) Front Trim - Grime - Small</p>	<p><b>Remarks</b> (R) Front Door, Molding - Scratch - Minimal / (L) Front Door, Molding - Scratch - Minimal / Bonnet, Headlight - Scratch - Minimal</p>
<b>Frame Evaluation :</b> <span style="float: right; color: red; font-weight: bold;">A</span>	<b>Functional Evaluation :</b> <span style="float: right; color: red; font-weight: bold;">A</span>
