General Information

Make	Toyota	Model	Vios
YOM	2025	Odo Meter Reading	8,743
Registration No.	FAT4347	Chassis No.	PA1B18F31S490223
CC	1.3	Transmission	CVT
Fuel Type	Gas	Type of Body	Sedan
Colour	Silver

Body / Panel Condition

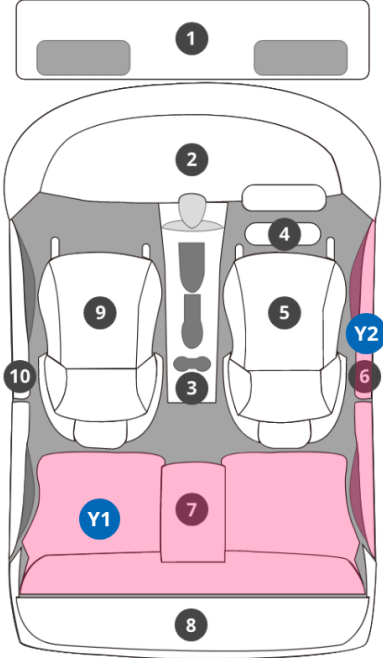
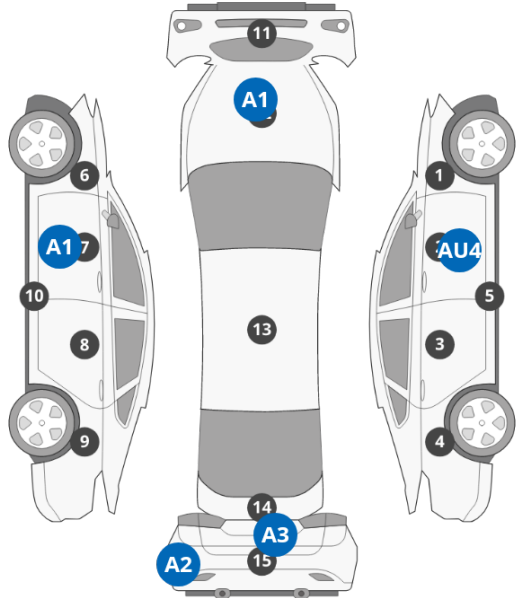
Interior Evaluation :	A	Exterior Evaluation :	C

<p>a : Cut, Fray d : Loose, Deformed k : Animal Hair s : Smell t : Cigarette Burns x : Defective y : Stain</p>		<p>A : Scratch AU : Scratch & Dent B : Modified C : Corrosion G : Stone chip P : Faded S : Rust SC : Rust & Corrosion U : Dent X : Defective Y : Crack, Gap</p>	
<p>Remarks (R) Front Trim - Grime - Small / Rear Seat - Grime - Minimal</p>		<p>Remarks (L) Front Fender - Repair Traces - Yes / (R) Front Door, Molding - Scratch & Dent - Large / Trunk Hood, Rear Gate - Scratch - Medium / Rear Bumper, Lamps, Panels - Scratch - Small / Bonnet, Headlight - Scratch - Minimal / (L) Front Door, Molding - Scratch - Minimal</p>	
Frame Evaluation :	A	Functional Evaluation :	A
<p>Remarks Defects not found</p>		<p>Remarks Spare Key - Issue - Unexist</p>
