General Information

Make	Toyota	Model	Vios
YOM	2024	Odo Meter Reading	66,332
Registration No.	NHM4503	Chassis No.	PA1B18F36P4236908
CC	1.3	Transmission	CVT
Fuel Type	Gas	Type of Body	Sedan
Colour	White

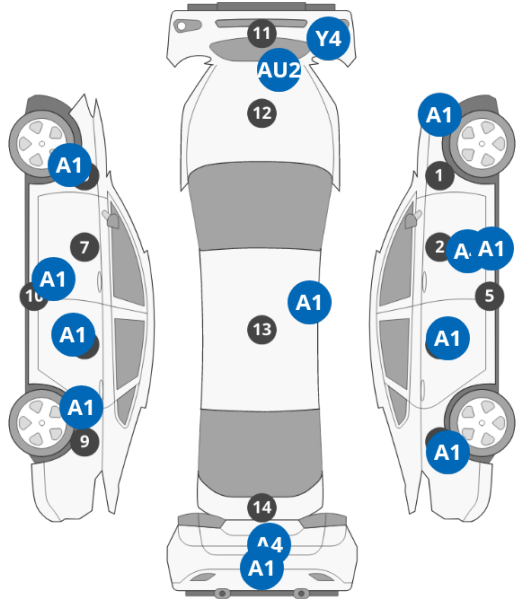
<p>A : Scratch AU : Scratch & Dent B : Modified C : Corrosion G : Stone chip P : Faded S : Rust SC : Rust & Corrosion U : Dent X : Defective Y : Crack, Gap</p>
Remarks Defects not found	Remarks (R) Front Fender, Molding - Scratch - Minimal / (R) Front Door, Molding - Scratch - Large / (R) Step, In-panel, Side Spoiler - Scratch - Minimal / (R) Rear Door, Molding - Scratch - Minimal / Roof - Scratch - Minimal / (R) Rear Fender, Molding - Scratch - Minimal / Trunk Hood, Rear Gate - Scratch - Large / Rear Bumper, Lamps, Panels - Scratch - Minimal / (L) Rear Fender, Molding - Scratch - Minimal / (L) Rear Door, Molding - Scratch - Minimal / (L) Front Door, Molding - Scratch - Minimal / (L) Front Fender, Molding - Scratch - Minimal / Bonnet, Headlight - Scratch & Dent - Small / Front Bumper, Grille, Lamps - Crack, Gap - Large

Inspector Notes
With Lto plate, with warranty booklet, with spare tire, with jack and tools, 2keys, Crack headlight and moist,cover under hood missing
