## General Information

| Make | Toyota | Model | Vios |
| YOM | 2019 | Mileage | 95,014 |
| Registration No. | EAB9955 | Chassis No. | PA1B13F35J4073145 |

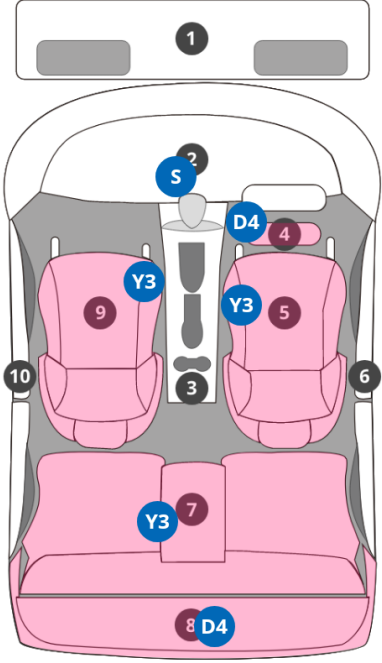
| <b>Remarks</b><br>(L) Front Seat - Grime - Medium / (L) Front Floor Mat - Worked - Large / (R) Front Seat - Grime - Medium / Rear Seat - Grime - Medium / Trunk Room - Worked - Large / Overall Interior - Smell - Yes | <b>Remarks</b><br>(R) Front Door - Repair Traces - Yes / (R) Front Fender - Repair Traces - Yes / (L) Rear Fender - Repair Traces - Yes / Trunk Hood, Rear Gate - Repair Traces - Yes / (R) Rear Fender - Repair Traces - Yes / Roof - Repair Traces - Yes / (L) Rear Door, Molding - Scratch - Medium / (L) Rear Fender, Molding - Scratch - Medium / Rear Bumper, Lamps, Panels - Scratch & Dent - Medium / (R) Rear Fender, Molding - Dent - Small / (R) Front Fender, Molding - Dent - Medium / (R) Rear Door, Molding - Scratch - Small / (L) Front Fender, Molding - Scratch - Small / Bonnet, Headlight - Dent - Small / Front Bumper, Grille, Lamps - Scratch & Dent - Medium / (R) Mirror - Scratch - Minimal / Trunk Hood, Rear Gate - Dent - Small / (L) Mirror - Faded(Color, Gloss) - Yes |
