General Information

Make	Toyota	Model	Vios
YOM	2024	Odo Meter Reading	53,926
Registration No.	NFS2510	Chassis No.	PA1B18F37R4240503
CC	1.3	Transmission	CVT
Fuel Type	Gas	Type of Body	Sedan
Colour	Red

Body / Panel Condition

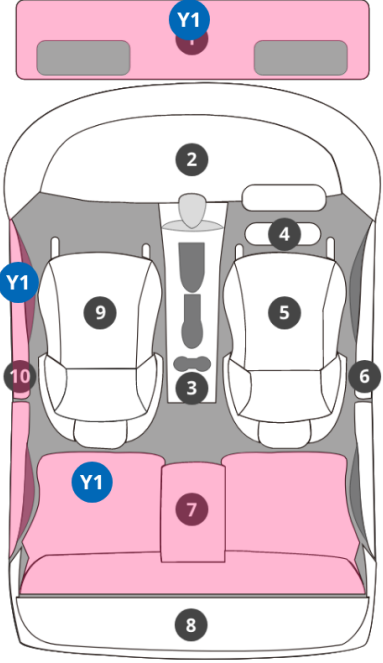
Interior Evaluation : A	Exterior Evaluation : D

<p>a : Cut, Fray d : Loose, Deformed k : Animal Hair s : Smell t : Cigarette Burns x : Defective y : Stain</p>

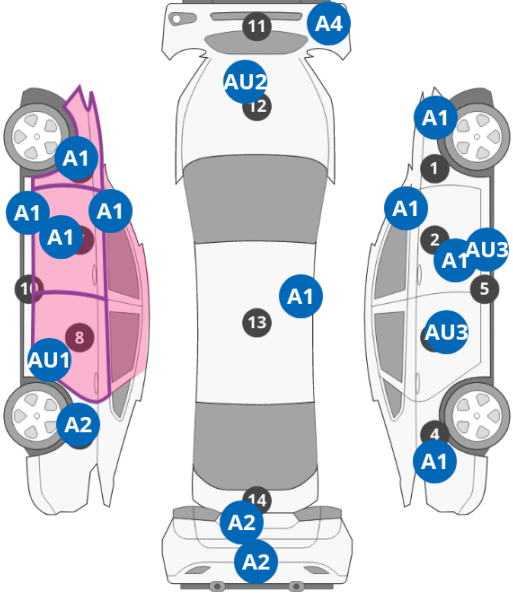
<p>A : Scratch AU : Scratch & Dent B : Modified C : Corrosion G : Stone chip P : Faded S : Rust SC : Rust & Corrosion U : Dent X : Defective Y : Crack, Gap</p>
<p>Remarks Ceiling - Grime - Minimal / (L) Front Trim - Grime - Minimal / Rear Seat - Grime - Minimal</p>	<p>Remarks (L) Front Fender - Repair Traces - Yes / (L) Front Door - Repair Traces - Yes / (L) Rear Door - Repair Traces - Yes / (R) Front Fender, Molding - Scratch - Minimal / (R) Mirror - Scratch - Minimal / (R) Front Door, Molding - Scratch - Minimal / (R) Step, In-panel, Side Spoiler - Scratch & Dent - Medium / Roof - Scratch - Minimal / (R) Rear Door, Molding - Scratch & Dent - Medium / (R) Rear Fender, Molding - Scratch - Minimal / Rear Bumper, Lamps, Panels - Scratch - Small / Trunk Hood, Rear Gate - Scratch - Small / (L) Rear Fender, Molding - Scratch - Small / (L) Rear Door, Molding - Repair mark - Yes / (L) Rear Door, Molding - Scratch & Dent - Minimal / (L) Front Door, Molding - Repair mark - Yes / (L) Front Fender, Molding - Repair mark - Yes / (L) Step, In-panel, Side Spoiler - Scratch - Minimal / (L) Front Door, Molding - Scratch - Minimal / (L) Mirror - Scratch - Minimal / (L) Front Fender, Molding - Scratch - Minimal / Front Bumper, Grille, Lamps - Scratch - Large / Bonnet, Headlight - Scratch & Dent - Small</p>
