General Information

Make	Geely	Model	Coolray
YOM	2023	Odo Meter Reading	69,552
Registration No.	DBH2832	Chassis No.	LB37622Z1PX412990
CC	1.5	Transmission	A/T
Fuel Type	Gas	Type of Body	SUV
Colour	Silver

Body / Panel Condition

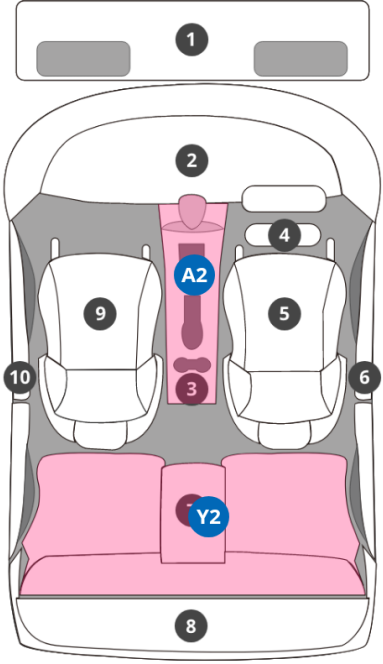
Interior Evaluation : A	Exterior Evaluation : E

<p>a : Cut, Fray d : Loose, Deformed k : Animal Hair s : Smell t : Cigarette Burns x : Defective y : Stain</p>

<p>A : Scratch AU : Scratch & Dent B : Modified C : Corrosion G : Stone chip P : Faded S : Rust SC : Rust & Corrosion U : Dent X : Defective Y : Crack, Gap</p>
<p>Remarks Console, Switches, Vents - Worn, Scratch, Cut, Crack - Small / Rear Seat - Grime - Small</p>	<p>Remarks Bonnet, Headlight - Crack, Gap - Large / Front Bumper, Grille, Lamps - Scratch & Dent - Large / (R) Front Door, Molding - Scratch & Dent - Small / Trunk Hood, Rear Gate - Crack, Gap - Large / Rear Bumper, Lamps, Panels - Scratch & Dent - Medium / (R) Rear Fender, Molding - Crack, Gap - Small / (L) Rear Fender, Molding - Scratch - Minimal / (R) Front Fender, Molding - Scratch - Minimal / (R) Rear Door, Molding - Scratch - Small / (L) Front Fender, Molding - Scratch - Minimal / (L) Step, In-panel, Side Spoiler - Scratch - Small / (L) Front Door, Molding - Scratch - Minimal / (L) Rear Door, Molding - Scratch - Minimal / Roof - Scratch - Small / (R) Step, In-panel, Side Spoiler - Scratch - Small</p>
