General Information

Make	Nissan	Model	Almera
YOM	2025	Odo Meter Reading	9,202
Registration No.	LAQ1209	Chassis No.	MNTBAAN18Z0061907
CC	1.0	Transmission	CVT
Fuel Type	Gas	Type of Body	Sedan
Colour	Gray

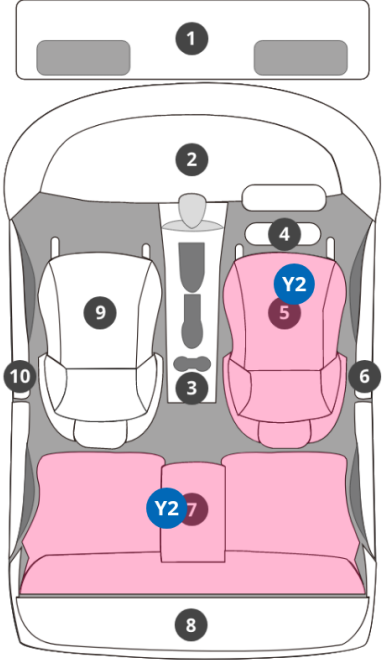
Interior Evaluation : A	Exterior Evaluation : C

<p>a : Cut, Fray d : Loose, Deformed k : Animal Hair s : Smell t : Cigarette Burns x : Defective y : Stain</p>

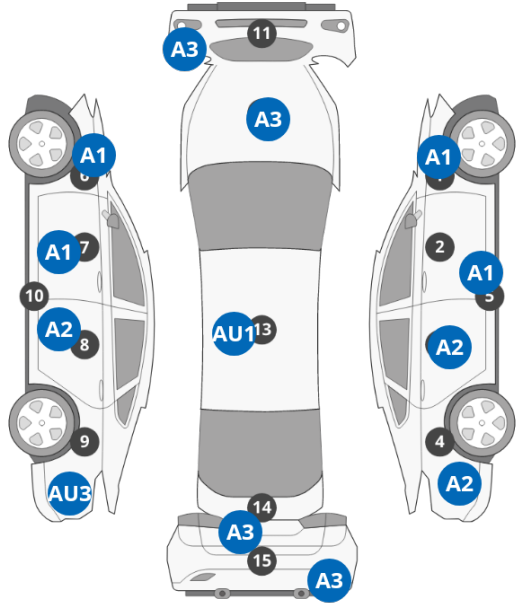
<p>A : Scratch AU : Scratch & Dent B : Modified C : Corrosion G : Stone chip P : Faded S : Rust SC : Rust & Corrosion U : Dent X : Defective Y : Crack, Gap</p>
Remarks (R) Front Seat - Grime - Small / Rear Seat - Grime - Small	Remarks (L) Rear Fender, Molding - Scratch & Dent - Medium / Trunk Hood, Rear Gate - Scratch - Medium / (R) Rear Fender, Molding - Scratch - Small / Rear Bumper, Lamps, Panels - Scratch - Medium / (R) Rear Door, Molding - Scratch - Small / (R) Step, In-panel, Side Spoiler - Scratch - Minimal / (R) Front Fender, Molding - Scratch - Minimal / Bonnet, Headlight - Scratch - Medium / Front Bumper, Grille, Lamps - Scratch - Medium / (L) Front Fender, Molding - Scratch - Minimal / (L) Front Door, Molding - Scratch - Minimal / (L) Rear Door, Molding - Scratch - Small / Roof - Scratch & Dent - Minimal
