General Information

Make	GAC Motor	Model	GAC GS8
YOM	2019	Odo Meter Reading	92,099
Registration No.	NDA5454	Chassis No.	LMGJS1G55K1140624
CC	2.0	Transmission	A/T
Fuel Type	Gas	Type of Body	Wagon
Colour	Black

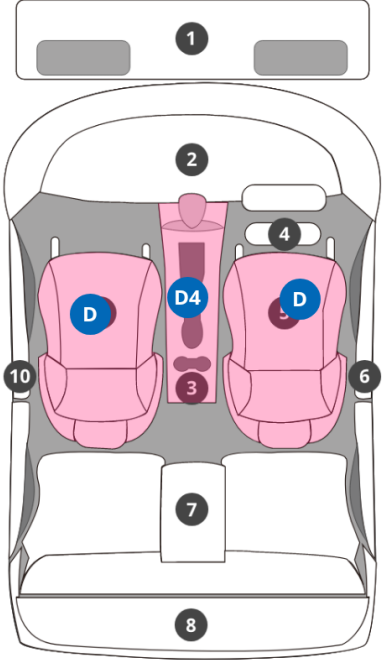
Interior Evaluation : C	Exterior Evaluation : E

<p>a : Cut, Fray d : Loose, Deformed k : Animal Hair s : Smell t : Cigarette Burns x : Defective y : Stain</p>

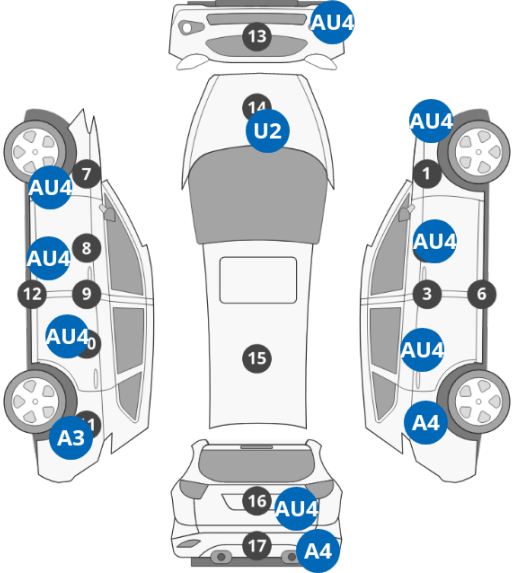
<p>A : Scratch AU : Scratch & Dent B : Modified C : Corrosion G : Stone chip P : Faded S : Rust SC : Rust & Corrosion U : Dent X : Defective Y : Crack, Gap</p>
Remarks (L) Front Seat - Worn - Yes / (R) Front Seat - Worn - Yes / Console, Switchs, Vents - Worked - Large	Remarks Front Bumper, Grille, Lamps - Scratch & Dent - Large / (R) Front Fender, Molding - Scratch & Dent - Large / (R) Front Door, Molding - Scratch & Dent - Large / (R) Rear Door, Molding - Scratch & Dent - Large / (R) Rear Fender, Molding - Scratch - Large / Rear Bumper, Lamps, Panels - Scratch - Large / Trunk Hood, Rear Gate - Scratch & Dent - Large / (L) Rear Fender, Molding - Scratch - Medium / (L) Rear Door, Molding - Scratch & Dent - Large / (L) Front Door, Molding - Scratch & Dent - Large / (L) Front Fender, Molding - Scratch & Dent - Large / Bonnet, Headlight - Dent - Small
