General Information

Make	Toyota	Model	Fortuner
YOM	2020	Odo Meter Reading	25,756
Registration No.	NFX8395	Chassis No.	MHFJB8GS2L1580391
CC	2.4	Transmission	A/T
Fuel Type	Diesel	Type of Body	SUV
Colour	Gray

Body / Panel Condition

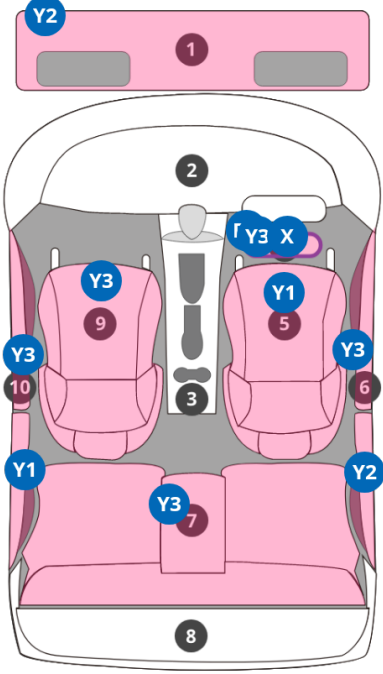
<p>a : Cut, Fray d : Loose, Deformed k : Animal Hair s : Smell t : Cigarette Burns x : Defective y : Stain</p>

<p>A : Scratch AU : Scratch & Dent B : Modified C : Corrosion G : Stone chip P : Faded S : Rust SC : Rust & Corrosion U : Dent X : Defective Y : Crack, Gap</p>
<p>Remarks (L) Front Seat - Grime - Medium / (R) Front Seat - Grime - Minimal / Overall Interior - Worn as per age - Yes / Rear Seat - Grime - Medium / (L) Front Floor Mat - Worked - Small / (L) Front Floor Mat - Grime - Medium / Mat Other - Missing - Yes / (R) Rear Trim - Grime - Small / (L) Rear Trim - Grime - Minimal / (R) Front Trim - Grime - Medium / (L) Front Trim - Grime - Medium / Ceiling - Grime - Small</p>	<p>Remarks (R) Front Fender - Repair Traces - Yes / Trunk Hood, Rear Gate - Repair Traces - Yes / (R) Rear Fender - Repair Traces - Yes / (R) Rear Door - Repair Traces - Yes / (R) Front Fender, Molding - Scratch - Minimal / (R) Mirror - Scratch - Minimal / (R) Step, In-panel, Side Spoiler - Scratch & Dent - Medium / (R) Front Door, Molding - Scratch - Small / (R) Rear Door, Molding - Crack, Gap - Medium / (R) Rear Fender, Molding - Dent - Medium / Rear Bumper, Lamps, Panels - Scratch - Small / Trunk Hood, Rear Gate - Scratch - Small / (L) Rear Fender, Molding - Scratch & Dent - Small / (L) Rear Door, Molding - Scratch - Small / (L) Front Door, Molding - Scratch & Dent - Small / (L) Mirror - Scratch - Minimal / (L) Front Fender, Molding - Scratch - Small / Front Bumper, Grille, Lamps - Scratch & Dent - Medium / Bonnet, Headlight - Scratch & Dent - Small / Roof - Scratch - Minimal</p>
