General Information

Make	Toyota	Model	Vios
YOM	2025	Odo Meter Reading	24,970
Registration No.	DBP8218	Chassis No.	PA1B18F30R4264383
CC	1.3	Transmission	CVT
Fuel Type	Gas	Type of Body	Sedan
Colour	Red

Body / Panel Condition

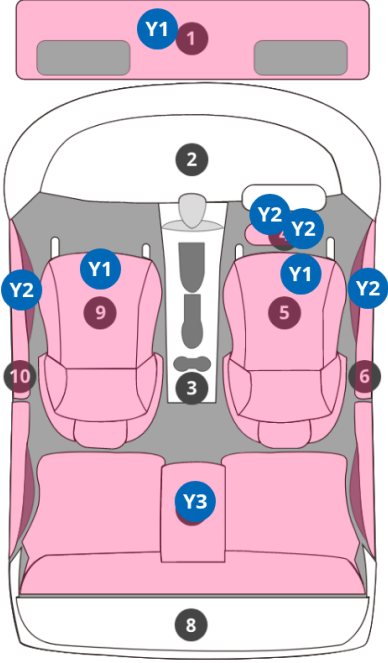
Interior Evaluation : B	Exterior Evaluation : C

<p>a : Cut, Fray d : Loose, Deformed k : Animal Hair s : Smell t : Cigarette Burns x : Defective y : Stain</p>

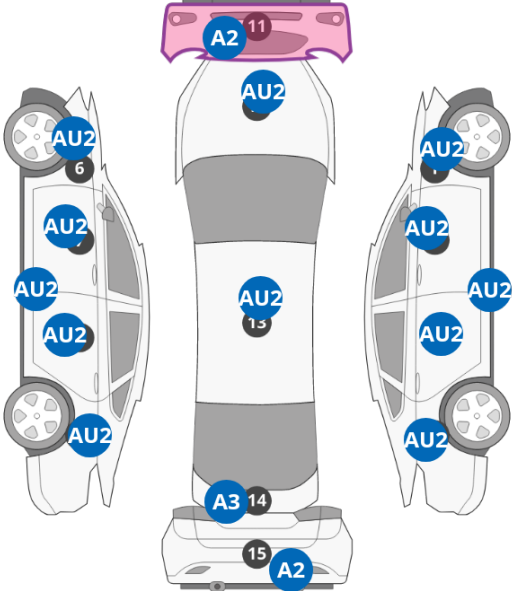
<p>A : Scratch AU : Scratch & Dent B : Modified C : Corrosion G : Stone chip P : Faded S : Rust SC : Rust & Corrosion U : Dent X : Defective Y : Crack, Gap</p>
<p>Remarks (L) Front Floor Mat - Grime - Small / (R) Front Floor Mat - Grime - Small / Rear Seat - Grime - Medium / (R) Front Seat - Grime - Minimal / (L) Front Seat - Grime - Minimal / (L) Front Trim - Grime - Small / (R) Front Trim - Grime - Small / Ceiling - Grime - Minimal</p>	<p>Remarks Trunk Hood, Rear Gate - Scratch - Medium / (L) Rear Fender, Molding - Scratch & Dent - Small / (L) Rear Door, Molding - Scratch & Dent - Small / (L) Front Door, Molding - Scratch & Dent - Small / Roof - Scratch & Dent - Small / (L) Front Fender, Molding - Scratch & Dent - Small / Bonnet, Headlight - Scratch & Dent - Small / (R) Front Fender, Molding - Scratch & Dent - Small / (R) Front Door, Molding - Scratch & Dent - Small / (R) Rear Door, Molding - Scratch & Dent - Small / (R) Rear Fender, Molding - Scratch & Dent - Small / Rear Bumper, Lamps, Panels - Scratch - Small / Front Bumper, Grille, Lamps - Scratch - Small / Front Bumper, Grille, Lamps - Repair mark - Yes</p>

<p>Inspector Notes</p>
<p>with LTO plate, with spare tire, with reverse camera, no spare key, with manual and warranty booklet, scratches on taillight and headlight.</p>
