General Information

Make	Toyota	Model	Wigo
YOM	2025	Odo Meter Reading	26,695
Registration No.	DBT1492	Chassis No.	MHKAA1BC1RJ029972
CC	1.0	Transmission	CVT
Fuel Type	Gas	Type of Body	Hatchback
Colour	Red

Body / Panel Condition

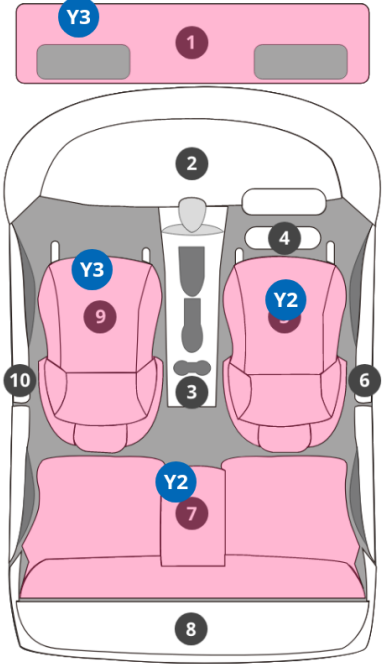
Interior Evaluation : B	Exterior Evaluation : D

<p>a : Cut, Fray d : Loose, Deformed k : Animal Hair s : Smell t : Cigarette Burns x : Defective y : Stain</p>

<p>A : Scratch AU : Scratch & Dent B : Modified C : Corrosion G : Stone chip P : Faded S : Rust SC : Rust & Corrosion U : Dent X : Defective Y : Crack, Gap</p>
Remarks (R) Front Seat - Grime - Small / (L) Front Seat - Grime - Medium / Ceiling - Grime - Medium / Rear Seat - Grime - Small	Remarks Roof - Repair Traces - Yes / (R) Mirror - Crack - Damaged / (R) Step, In-panel, Side Spoiler - Scratch & Dent - Small / (R) Front Fender, Molding - Crack, Gap - Medium / (R) Front Door, Molding - Scratch & Dent - Small / (R) Rear Fender, Molding - Scratch - Small / (R) Rear Door, Molding - Scratch - Small / Rear Bumper, Lamps, Panels - Scratch - Small / Trunk Hood, Rear Gate - Scratch - Minimal / (L) Rear Fender, Molding - Scratch - Medium / (L) Rear Door, Molding - Scratch & Dent - Minimal / (L) Step, In-panel, Side Spoiler - Scratch - Minimal / (L) Front Door, Molding - Scratch - Minimal / (L) Mirror - Scratch - Minimal / (L) Front Fender, Molding - Scratch - Small / Front Bumper, Grille, Lamps - Scratch - Medium / Member (Bolted) - Dent - Yes / Bonnet, Headlight - Scratch - Minimal / Roof - Scratch - Minimal

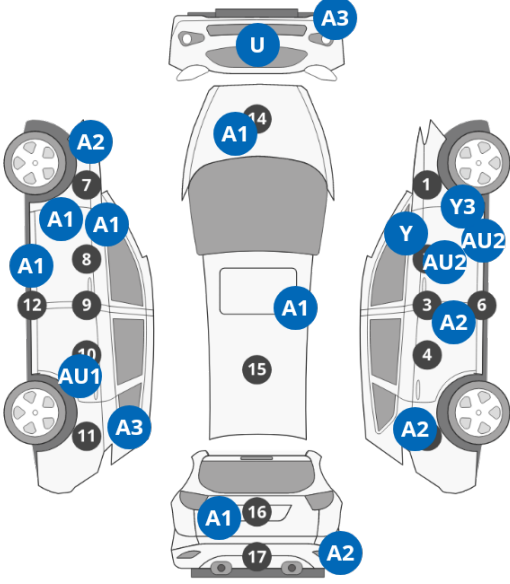
Inspector Notes
with warranty booklet and jack, no tools, with spare tire, with LTO plate, scratches on tail light, right side mirror crack/damaged
