General Information

Make	Toyota	Model	Raize
YOM	2024	Odo Meter Reading	17,246
Registration No.	EAJ4662	Chassis No.	MHKAB1BA7RJ088603
CC	1.2	Transmission	M/T
Fuel Type	Gas	Type of Body	SUV
Colour	Silver

Body / Panel Condition

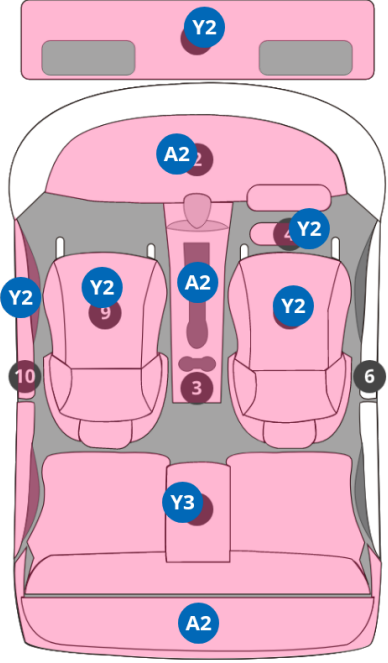
Interior Evaluation : C	Exterior Evaluation : C

<p>a : Cut, Fray d : Loose, Deformed k : Animal Hair s : Smell t : Cigarette Burns x : Defective y : Stain</p>

<p>A : Scratch AU : Scratch & Dent B : Modified C : Corrosion G : Stone chip P : Faded S : Rust SC : Rust & Corrosion U : Dent X : Defective Y : Crack, Gap</p>
Remarks (R) Front Seat - Grime - Small / Rear Seat - Grime - Medium / (L) Front Trim - Grime - Small / (L) Front Seat - Grime - Small / (L) Front Floor Mat - Grime - Small / Ceiling - Grime - Small / Dashboard - Worn, Scratch, Cut, Crack - Small / Trunk Room - Worn, Scratch, Cut, Crack - Small / Console, Switchs, Vents - Worn, Scratch, Cut, Crack - Small	Remarks (R) Front Fender - Repair Traces - Yes / Bonnet - Repair Traces - Yes / (L) Front Fender - Repair Traces - Yes / Trunk Hood, Rear Gate - Scratch - Small / (L) Rear Fender, Molding - Scratch - Minimal / (L) Rear Door, Molding - Scratch - Medium / (L) Mirror - Scratch - Minimal / (L) Front Door, Molding - Scratch - Small / (L) Front Fender, Molding - Scratch - Minimal / Rear Bumper, Lamps, Panels - Scratch - Small / (R) Rear Fender, Molding - Scratch - Minimal / (R) Rear Door, Molding - Scratch - Minimal / (R) Front Door, Molding - Scratch - Medium / (R) Mirror - Crack - Damaged / (R) Front Fender, Molding - Scratch - Minimal / Bonnet, Headlight - Scratch - Minimal / Front Bumper, Grille, Lamps - Scratch - Small / Roof - Dent - Small
