## General Information

| Make | Toyota | Model | Wigo |
| YOM | 2023 | Mileage | 47,159 |
| Registration No. | DAS8410 | Chassis No. | MHKA4DF5FNJ074984 |

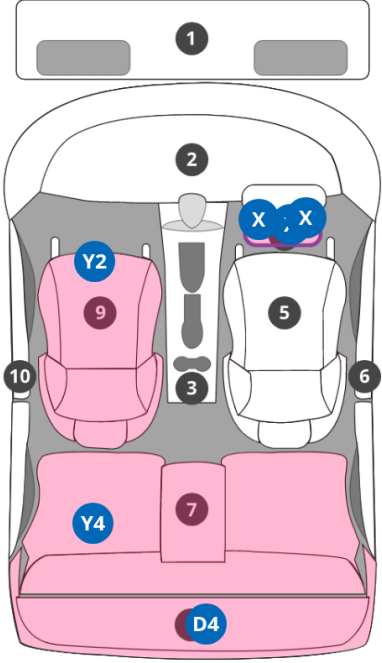
| Interior Evaluation : <span style="color: red;">C</span> | Exterior Evaluation : <span style="color: red;">C</span> |
| <b>Remarks</b><br>Mat Other - Missing - Yes / (L) Front Floor Mat - Missing - Yes / (R) Front Floor Mat - Missing - Yes / (L) Front Seat - Grime - Small / Rear Seat - Grime - Large / Trunk Room - Loose, Deformed - Large | <b>Remarks</b><br>Front Bumper, Grille, Lamps - Scratch & Dent - Large / (L) Front Door, Molding - Scratch & Dent - Small / Rear Bumper, Lamps, Panels - Crack, Gap - Medium / (R) Front Door, Molding - Dent - Minimal / (R) Mirror - Scratch - Small / (R) Rear Door, Molding - Scratch - Small / Roof - Dent - Small / (L) Mirror - Scratch - Small / (L) Rear Door, Molding - Scratch - Small |
