General Information

Body / Panel Condition

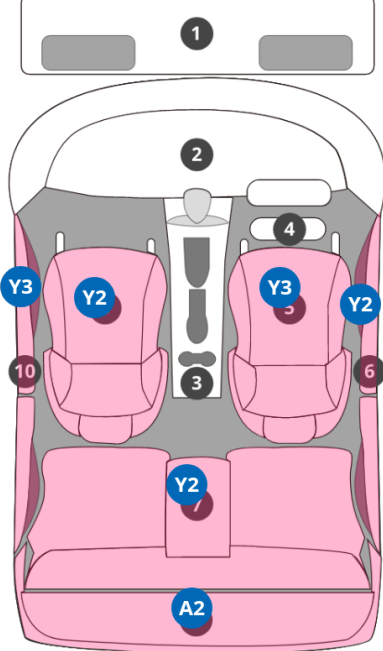
<p>a : Cut, Fray d : Loose, Deformed k : Animal Hair s : Smell t : Cigarette Burns x : Defective y : Stain</p>

<p>A : Scratch AU : Scratch & Dent B : Modified C : Corrosion G : Stone chip P : Faded S : Rust SC : Rust & Corrosion U : Dent X : Defective Y : Crack, Gap</p>
<p>Remarks (R) Front Seat - Grime - Medium / (R) Front Trim - Grime - Small / Trunk Room - Worn, Scratch, Cut, Crack - Small / Rear Seat - Grime - Small / (L) Front Trim - Grime - Medium / (L) Front Seat - Grime - Small</p>	<p>Remarks Trunk Hood, Rear Gate - Scratch - Medium / Rear Bumper, Lamps, Panels - Scratch - Large / (R) Rear Fender, Molding - Scratch - Small / (R) Rear Door, Molding - Scratch - Large / (R) Front Door, Molding - Scratch & Dent - Minimal / (R) Mirror - Scratch - Minimal / (R) Front Fender, Molding - Scratch - Minimal / Bonnet, Headlight - Scratch - Small / Front Bumper, Grille, Lamps - Scratch - Small / (L) Front Fender, Molding - Scratch - Minimal / (L) Front Door, Molding - Scratch - Small / (L) Rear Door, Molding - Scratch - Small / (L) Rear Fender, Molding - Scratch - Minimal / Roof - Scratch - Small / Member (Bolted) - Rust, Corrosion - Yes</p>
