General Information

Make	Toyota	Model	Vios
YOM	2024	Odo Meter Reading	48,060
Registration No.	NEY4257	Chassis No.	PA1B18F33R4255046
CC	1.3	Transmission	CVT
Fuel Type	Gas	Type of Body	Sedan
Colour	Red Mica Metallic

Body / Panel Condition

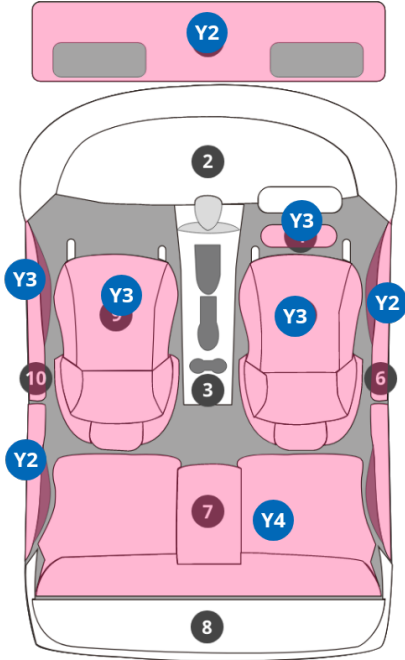
Interior Evaluation : C	Exterior Evaluation : E

<p>a : Cut, Fray d : Loose, Deformed k : Animal Hair s : Smell t : Cigarette Burns x : Defective y : Stain</p>

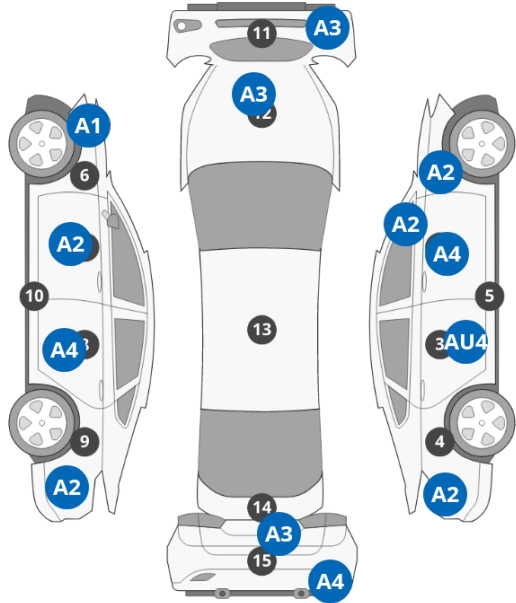
<p>A : Scratch AU : Scratch & Dent B : Modified C : Corrosion G : Stone chip P : Faded S : Rust SC : Rust & Corrosion U : Dent X : Defective Y : Crack, Gap</p>
<p>Remarks (L) Front Seat - Grime - Medium / Rear Seat - Grime - Large / (R) Front Seat - Grime - Medium / (R) Front Trim - Grime - Small / (L) Rear Trim - Grime - Small / (L) Front Trim - Grime - Medium / Ceiling - Grime - Small / (L) Front Floor Mat - Grime - Medium</p>	<p>Remarks (R) Rear Fender, Molding - Scratch - Small / (R) Rear Door, Molding - Scratch & Dent - Large / (R) Front Door, Molding - Scratch - Large / (R) Front Fender, Molding - Scratch - Small / (R) Mirror - Scratch - Small / Bonnet, Headlight - Scratch - Medium / Front Bumper, Grille, Lamps - Scratch - Medium / (L) Front Fender, Molding - Scratch - Minimal / (L) Front Door, Molding - Scratch - Small / (L) Rear Door, Molding - Scratch - Large / (L) Rear Fender, Molding - Scratch - Small / Trunk Hood, Rear Gate - Scratch - Medium / Rear Bumper, Lamps, Panels - Scratch - Large</p>
