## General Information

<b>Make</b>	Toyota	<b>Model</b>	Rush
<b>YOM</b>	2022	<b>Odo Meter Reading</b>	63,469
<b>Registration No.</b>	NFD7503	<b>Chassis No.</b>	MHKE8FF3PNK042240
<b>CC</b>	1.5	<b>Transmission</b>	A/T
<b>Fuel Type</b>	Gas	<b>Type of Body</b>	SUV
<b>Colour</b>	Black

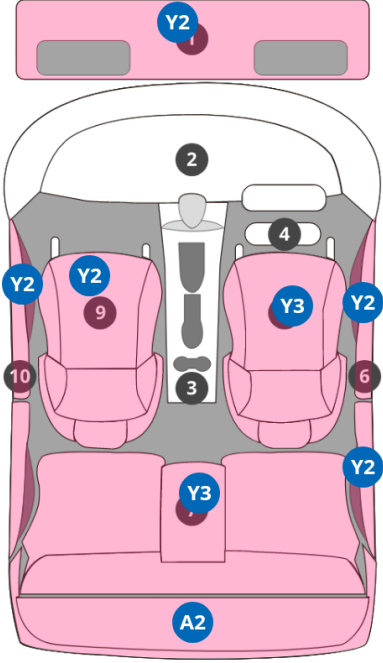
<b>Interior Evaluation :</b> <span style="float: right; color: red; font-weight: bold;">C</span>	<b>Exterior Evaluation :</b> <span style="float: right; color: red; font-weight: bold;">D</span>

<p><b>a</b> : Cut, Fray <b>d</b> : Loose, Deformed <b>k</b> : Animal Hair <b>s</b> : Smell <b>t</b> : Cigarette Burns <b>x</b> : Defective <b>y</b> : Stain</p>

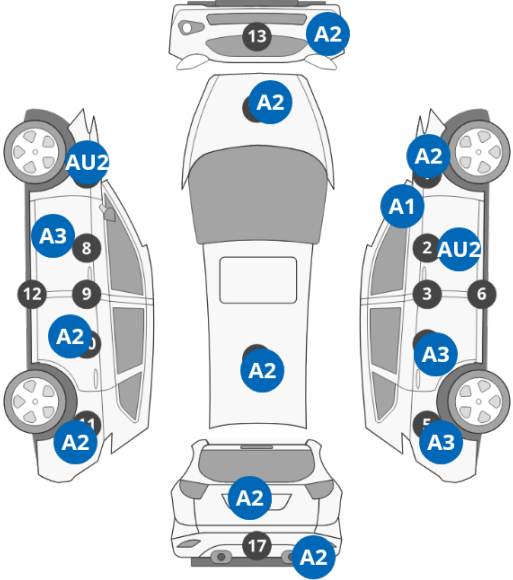
<p><b>A</b> : Scratch <b>AU</b> : Scratch &amp; Dent <b>B</b> : Modified <b>C</b> : Corrosion <b>G</b> : Stone chip <b>P</b> : Faded <b>S</b> : Rust <b>SC</b> : Rust &amp; Corrosion <b>U</b> : Dent <b>X</b> : Defective <b>Y</b> : Crack, Gap</p>
<p><b>Remarks</b> (R) Front Seat - Grime - Medium / (R) Front Trim - Grime - Small / Rear Seat - Grime - Medium / (R) Rear Trim - Grime - Small / Trunk Room - Worn, Scratch, Cut, Crack - Small / (L) Front Seat - Grime - Small / (L) Front Trim - Grime - Small / Ceiling - Grime - Small</p>	<p><b>Remarks</b> (L) Front Fender, Molding - Scratch &amp; Dent - Small / (L) Front Door, Molding - Scratch - Medium / (L) Rear Door, Molding - Scratch - Small / (L) Rear Fender, Molding - Scratch - Small / Trunk Hood, Rear Gate - Scratch - Small / Rear Bumper, Lamps, Panels - Scratch - Small / (R) Rear Fender, Molding - Scratch - Medium / (R) Rear Door, Molding - Scratch - Medium / (R) Front Door, Molding - Scratch &amp; Dent - Small / (R) Mirror - Scratch - Minimal / (R) Front Fender, Molding - Scratch - Small / Bonnet, Headlight - Scratch - Small / Front Bumper, Grille, Lamps - Scratch - Small / Roof - Scratch - Small</p>
