General Information

Make	Toyota	Model	Avanza
YOM	2023	Odo Meter Reading	27,033
Registration No.	NFP7518	Chassis No.	MHFAA1BY4N0006826
CC	1.3	Transmission	M/T
Fuel Type	Gas	Type of Body	MPV
Colour	Green

Body / Panel Condition

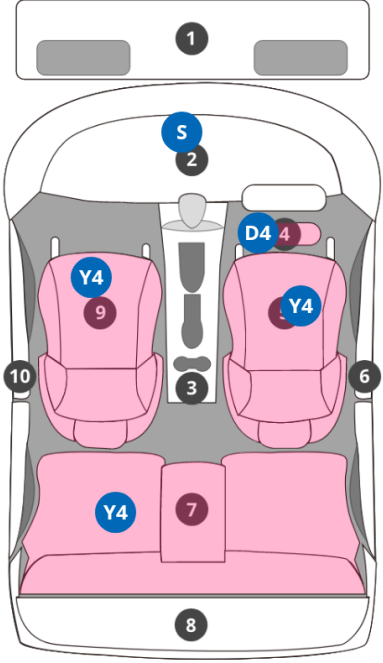
Interior Evaluation : C	Exterior Evaluation : E

<p>a : Cut, Fray d : Loose, Deformed k : Animal Hair s : Smell t : Cigarette Burns x : Defective y : Stain</p>

<p>A : Scratch AU : Scratch & Dent B : Modified C : Corrosion G : Stone chip P : Faded S : Rust SC : Rust & Corrosion U : Dent X : Defective Y : Crack, Gap</p>
<p>Remarks Rear Seat - Grime - Large / Overall Interior - Smell - Yes / (R) Front Seat - Grime - Large / (L) Front Seat - Grime - Large / (L) Front Floor Mat - Worked - Large</p>	<p>Remarks (R) Front Fender, Molding - Scratch & Dent - Small / (R) Front Door, Molding - Scratch - Small / (R) Rear Door, Molding - Scratch - Large / (R) Step, In-panel, Side Spoiler - Scratch & Dent - Large / (R) Rear Fender, Molding - Scratch - Small / Rear Bumper, Lamps, Panels - Scratch & Dent - Medium / Trunk Hood, Rear Gate - Scratch - Small / (L) Rear Fender, Molding - Scratch & Dent - Large / (L) Rear Door, Molding - Scratch & Dent - Large / (L) Front Door, Molding - Scratch - Small / (L) Front Fender, Molding - Scratch - Minimal / Front Bumper, Grille, Lamps - Scratch & Dent - Medium / Bonnet, Headlight - Dent - Small</p>
