General Information

Make	Toyota	Model	Fortuner
YOM	2024	Odo Meter Reading	46,773
Registration No.	NFR1906	Chassis No.	MHFAA3GS0P0747767
CC	2.8	Transmission	A/T
Fuel Type	Diesel	Type of Body	SUV
Colour	Black

Body / Panel Condition

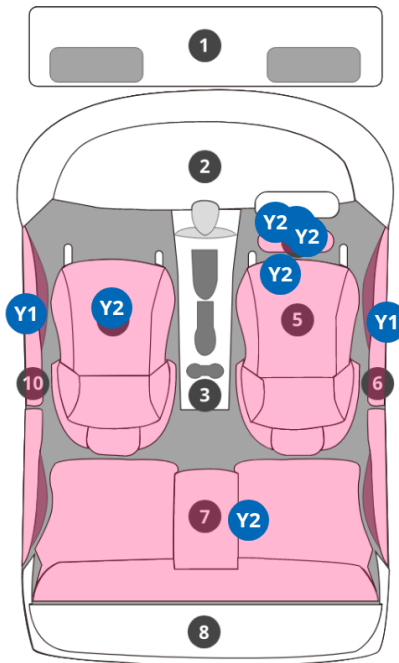
Interior Evaluation : B	Exterior Evaluation : C

<p>a : Cut, Fray d : Loose, Deformed k : Animal Hair s : Smell t : Cigarette Burns x : Defective y : Stain</p>

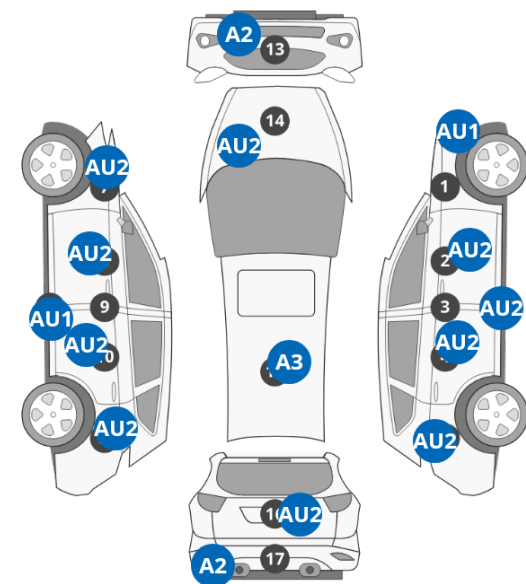
<p>A : Scratch AU : Scratch & Dent B : Modified C : Corrosion G : Stone chip P : Faded S : Rust SC : Rust & Corrosion U : Dent X : Defective Y : Crack, Gap</p>
<p>Remarks (L) Front Floor Mat - Grime - Medium / (L) Front Seat - Grime - Small / (R) Front Seat - Grime - Small / Rear Seat - Grime - Small / (L) Front Trim - Grime - Minimal / (R) Front Trim - Grime - Minimal / (R) Front Floor Mat - Grime - Small / Mat Other - Grime - Small</p>	<p>Remarks (L) Rear Door, Molding - Scratch & Dent - Small / (L) Rear Fender, Molding - Scratch & Dent - Small / Trunk Hood, Rear Gate - Scratch & Dent - Small / Rear Bumper, Lamps, Panels - Scratch - Small / (L) Front Door, Molding - Scratch & Dent - Small / (L) Step, In-panel, Side Spoiler - Scratch & Dent - Minimal / (L) Front Fender, Molding - Scratch & Dent - Small / Front Bumper, Grille, Lamps - Scratch - Small / Bonnet, Headlight - Scratch & Dent - Small / (R) Front Fender, Molding - Scratch & Dent - Minimal / (R) Front Door, Molding - Scratch & Dent - Small / (R) Rear Door, Molding - Scratch & Dent - Small / (R) Rear Fender, Molding - Scratch & Dent - Small / (R) Step, In-panel, Side Spoiler - Scratch & Dent - Small / Roof - Scratch - Medium</p>
