General Information

Make	Toyota	Model	Fortuner
YOM	2024	Odo Meter Reading	39,679
Registration No.	NFR6728	Chassis No.	MHFCB3GS3R0495831
CC	2.4	Transmission	A/T
Fuel Type	Diesel	Type of Body	SUV
Colour	White

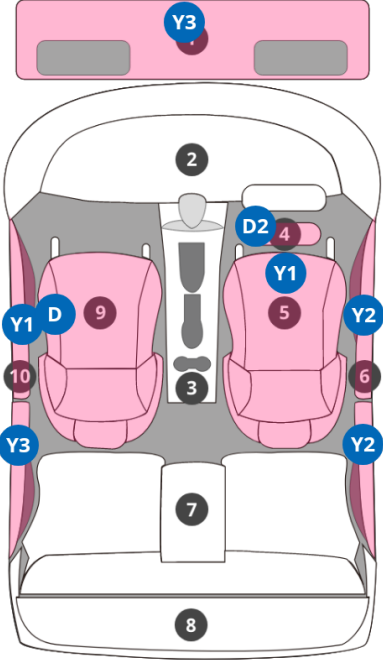
Interior Evaluation : C	Exterior Evaluation : D

<p>a : Cut, Fray d : Loose, Deformed k : Animal Hair s : Smell t : Cigarette Burns x : Defective y : Stain</p>

<p>A : Scratch AU : Scratch & Dent B : Modified C : Corrosion G : Stone chip P : Faded S : Rust SC : Rust & Corrosion U : Dent X : Defective Y : Crack, Gap</p>
<p>Remarks Ceiling - Grime - Medium / (R) Rear Trim - Grime - Small / (R) Front Trim - Grime - Small / (L) Front Trim - Grime - Minimal / (L) Rear Trim - Grime - Medium / (R) Front Seat - Grime - Minimal / (L) Front Seat - Worn - Yes / (L) Front Floor Mat - Worked - Small</p>	<p>Remarks (R) Front Fender, Molding - Scratch - Small / (R) Mirror - Scratch - Minimal / (R) Front Door, Molding - Scratch & Dent - Small / (R) Rear Door, Molding - Scratch - Small / (R) Rear Fender, Molding - Scratch - Medium / Rear Bumper, Lamps, Panels - Scratch - Medium / Trunk Hood, Rear Gate - Scratch & Dent - Small / (L) Rear Fender, Molding - Scratch - Small / (L) Front Door, Molding - Scratch - Small / (L) Rear Door, Molding - Scratch & Dent - Minimal / (L) Mirror - Scratch - Minimal / (L) Front Fender, Molding - Scratch - Small / Front Bumper, Grille, Lamps - Scratch - Large / Bonnet, Headlight - Scratch - Minimal / Roof - Scratch - Minimal</p>

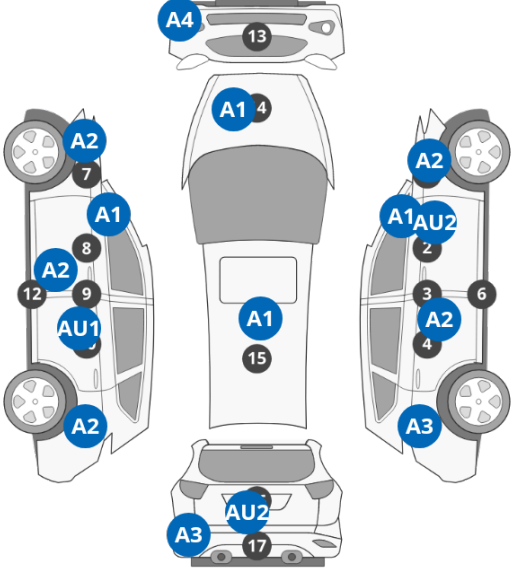
<p>Inspector Notes</p>
<p>with warranty booklet, no jack and tools, with spare tire, with LTO plate, scratches on tail light</p>
