General Information

Make	Toyota	Model	Hilux
YOM	2024	Odo Meter Reading	16,876
Registration No.	NHG9214	Chassis No.	MR0JB8DD1P3221577
CC	2.4	Transmission	A/T
Fuel Type	Diesel	Type of Body	Pickup
Colour	Silver

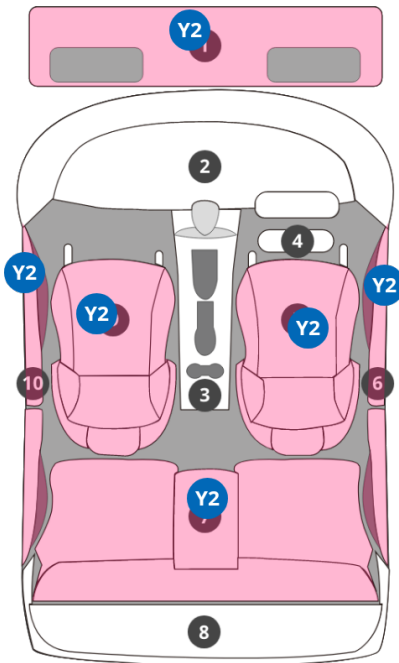
Interior Evaluation : B	Exterior Evaluation : D

<p>a : Cut, Fray d : Loose, Deformed k : Animal Hair s : Smell t : Cigarette Burns x : Defective y : Stain</p>

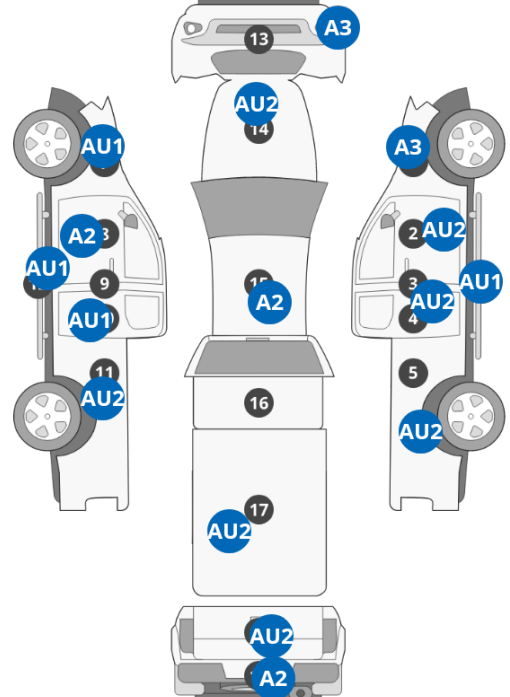
<p>A : Scratch AU : Scratch & Dent B : Modified C : Corrosion G : Stone chip P : Faded S : Rust SC : Rust & Corrosion U : Dent X : Defective Y : Crack, Gap</p>
<p>Remarks (L) Front Seat - Grime - Small / (R) Front Seat - Grime - Small / Rear Seat - Grime - Small / (L) Front Trim - Grime - Small / (R) Front Trim - Grime - Small / Ceiling - Grime - Small</p>	<p>Remarks (L) Rear Door, Molding - Scratch & Dent - Minimal / (L) Side Gate - Scratch & Dent - Small / (L) Front Door, Molding - Scratch - Small / (L) Front Fender, Molding - Scratch & Dent - Minimal / Front Bumper, Grille, Lamps - Scratch - Medium / (R) Front Fender, Molding - Scratch - Medium / Bonnet, Headlight - Scratch & Dent - Small / (R) Front Door, Molding - Scratch & Dent - Small / (R) Rear Door, Molding - Scratch & Dent - Small / Cargo Bed Floor - Scratch & Dent - Small / (R) Side Gate - Scratch & Dent - Small / Rear Gate - Scratch & Dent - Small / Rear Bumper, Lamps, Panels - Scratch - Small / Roof - Scratch - Small / (L) Step, In-panel, Side Spoiler - Scratch & Dent - Minimal / (R) Step, In-panel, Side Spoiler - Scratch & Dent - Minimal</p>
