General Information

Make	Toyota	Model	Vios
YOM	2024	Odo Meter Reading	11,724
Registration No.	NHH6976	Chassis No.	PA1B18F31R4242733
CC	1.3	Transmission	CVT
Fuel Type	Gas	Type of Body	Sedan
Colour	Silver

Body / Panel Condition

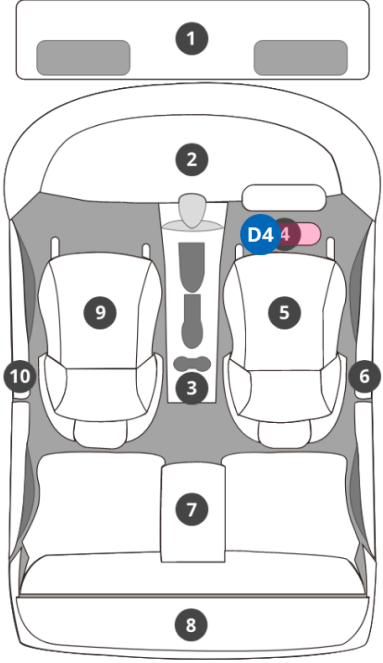
Interior Evaluation : C	Exterior Evaluation : B

<p>a : Cut, Fray d : Loose, Deformed k : Animal Hair s : Smell t : Cigarette Burns x : Defective y : Stain</p>

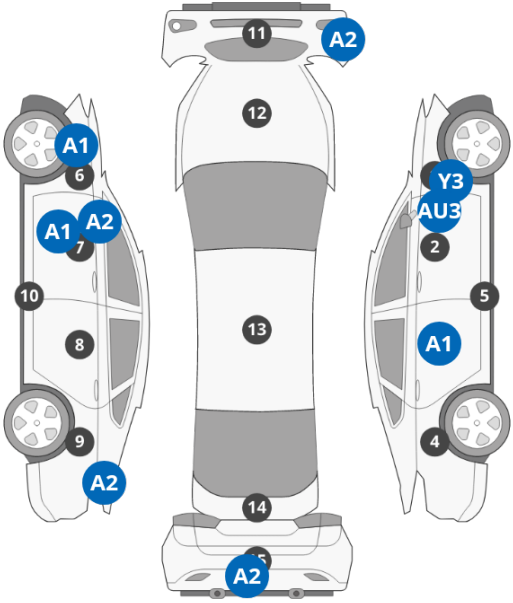
<p>A : Scratch AU : Scratch & Dent B : Modified C : Corrosion G : Stone chip P : Faded S : Rust SC : Rust & Corrosion U : Dent X : Defective Y : Crack, Gap</p>
<p>Remarks (L) Front Floor Mat - Worked - Large</p>	<p>Remarks (R) Front Fender, Molding - Crack, Gap - Medium / (R) Front Door, Molding - Scratch & Dent - Medium / Rear Bumper, Lamps, Panels - Scratch - Small / (L) Rear Fender, Molding - Scratch - Small / (L) Mirror - Scratch - Small / (L) Front Door, Molding - Scratch - Minimal / (R) Rear Door, Molding - Scratch - Minimal / (L) Front Fender, Molding - Scratch - Minimal / Front Bumper, Grille, Lamps - Scratch - Small</p>
Frame Evaluation : A	Functional Evaluation : A
<p>Remarks Defects not found</p>	<p>Remarks Defects not found</p>
