## General Information

| Make | Toyota | Model | Vios |
| YOM | 2022 | Mileage | 76,612 |

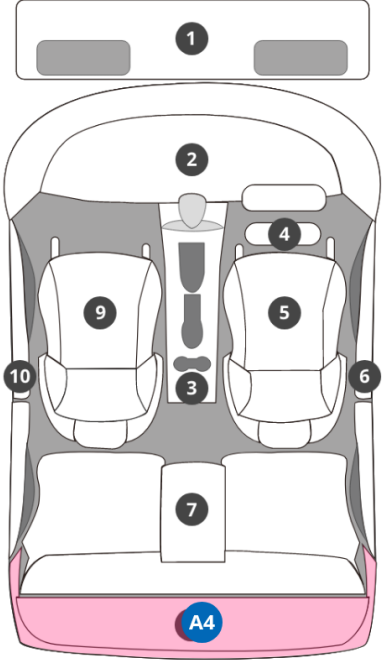
| <b>Interior Evaluation :</b> <span style="color: red; font-weight: bold;">C</span> | <b>Exterior Evaluation :</b> <span style="color: red; font-weight: bold;">C</span> |
| <b>Remarks</b><br>Trunk Room - Worn, Scratch, Cut, Crack - Large | <b>Remarks</b><br>Trunk Hood, Rear Gate - Repair Traces - Yes / (R) Rear Door - Repair Traces - Yes / Front Bumper, Grille, Lamps - Scratch - Large / (L) Front Fender, Molding - Dent - Minimal / (L) Mirror - Scratch - Small / Rear Bumper, Lamps, Panels - Scratch - Large / (L) Rear Door, Molding - Dent - Minimal / (L) Rear Fender, Molding - Scratch & Dent - Medium / Trunk Hood, Rear Gate - Dent - Minimal / (R) Rear Fender, Molding - Scratch - Small / Roof - Dent - Minimal / (R) Step, In-panel, Side Spoiler - Dent - Medium |
