General Information

Make	Toyota	Model	Vios
YOM	2024	Odo Meter Reading	6,168
Registration No.	NHM4093	Chassis No.	PA1B18F3XP4237981
CC	1.3	Transmission	CVT
Fuel Type	Gas	Type of Body	Sedan
Colour	Red Mica Metallic

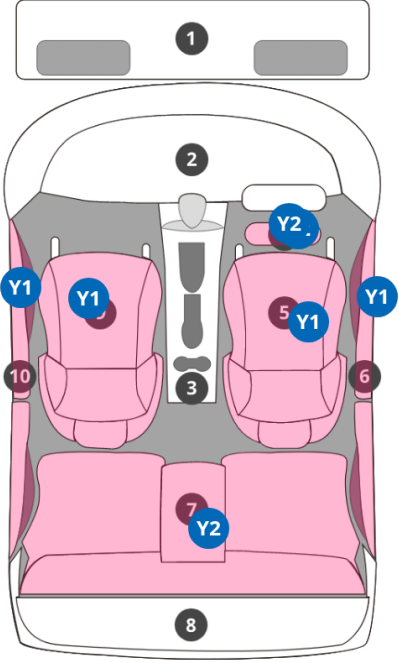
Interior Evaluation : B	Exterior Evaluation : C

<p>A : Scratch AU : Scratch & Dent B : Modified C : Corrosion G : Stone chip P : Faded S : Rust SC : Rust & Corrosion U : Dent X : Defective Y : Crack, Gap</p>
<p>Remarks (L) Front Seat - Grime - Minimal / (R) Front Seat - Grime - Minimal / Rear Seat - Grime - Small / (L) Front Trim - Grime - Minimal / (R) Front Trim - Grime - Minimal / (L) Front Floor Mat - Grime - Small / (R) Front Floor Mat - Grime - Small</p>	<p>Remarks (R) Rear Door, Molding - Scratch & Dent - Small / (R) Step, In-panel, Side Spoiler - Scratch & Dent - Minimal / (R) Front Door, Molding - Scratch & Dent - Small / (R) Front Fender, Molding - Scratch & Dent - Minimal / Bonnet, Headlight - Scratch & Dent - Small / Front Bumper, Grille, Lamps - Scratch - Small / (L) Front Fender, Molding - Scratch & Dent - Small / (L) Front Door, Molding - Scratch - Medium / (L) Step, In-panel, Side Spoiler - Scratch & Dent - Minimal / (L) Rear Door, Molding - Scratch & Dent - Small / (L) Rear Fender, Molding - Scratch - Medium / Roof - Scratch & Dent - Small / Trunk Hood, Rear Gate - Scratch & Dent - Small / Rear Bumper, Lamps, Panels - Scratch - Small / (R) Rear Fender, Molding - Scratch & Dent - Small</p>
