General Information

Make	Toyota	Model	Vios
YOM	2024	Odo Meter Reading	86,985
Registration No.	NHS3405	Chassis No.	PA1B18F39R4259425
CC	1.3	Transmission	CVT
Fuel Type	Gas	Type of Body	Sedan
Colour	Blue

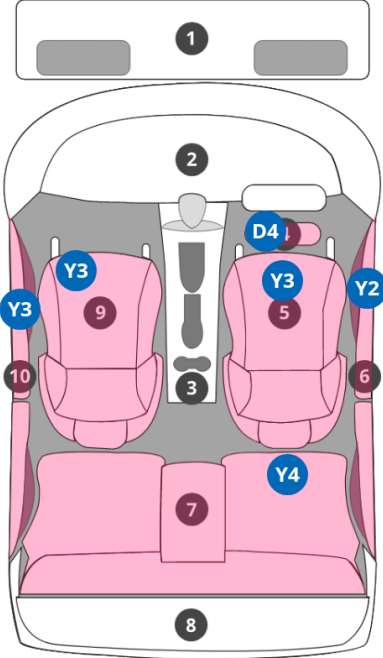
Interior Evaluation : C	Exterior Evaluation : E

<p>a : Cut, Fray d : Loose, Deformed k : Animal Hair s : Smell t : Cigarette Burns x : Defective y : Stain</p>

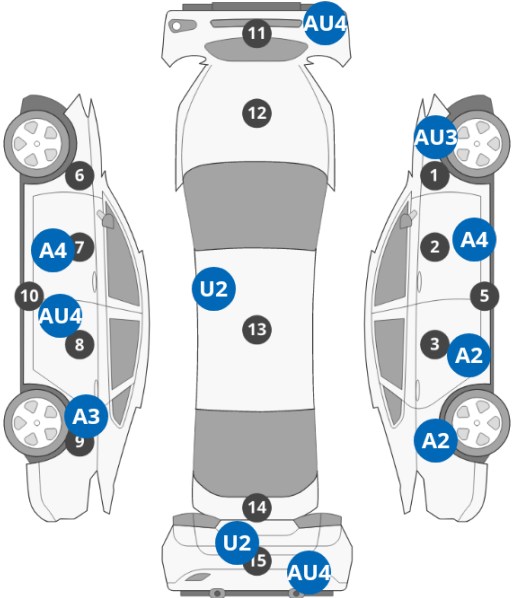
<p>A : Scratch AU : Scratch & Dent B : Modified C : Corrosion G : Stone chip P : Faded S : Rust SC : Rust & Corrosion U : Dent X : Defective Y : Crack, Gap</p>
<p>Remarks Rear Seat - Grime - Large / (R) Front Trim - Grime - Small / (R) Front Seat - Grime - Medium / (L) Front Trim - Grime - Medium / (L) Front Floor Mat - Worked - Large / (L) Front Seat - Grime - Medium</p>	<p>Remarks (L) Rear Door, Molding - Scratch & Dent - Large / (L) Front Door, Molding - Scratch - Large / (L) Rear Fender, Molding - Scratch - Medium / Rear Bumper, Lamps, Panels - Scratch & Dent - Large / Trunk Hood, Rear Gate - Dent - Small / (R) Rear Fender, Molding - Scratch - Small / (R) Rear Door, Molding - Scratch - Small / (R) Front Door, Molding - Scratch - Large / (R) Front Fender, Molding - Scratch & Dent - Medium / Front Bumper, Grille, Lamps - Scratch & Dent - Large / Roof - Dent - Small</p>
