General Information

Make	Toyota	Model	Vios
YOM	2025	Odo Meter Reading	52,105
Registration No.	NHU3120	Chassis No.	PA1B18F36R4270916
CC	1.3	Transmission	CVT
Fuel Type	Gas	Type of Body	Sedan
Colour	Green

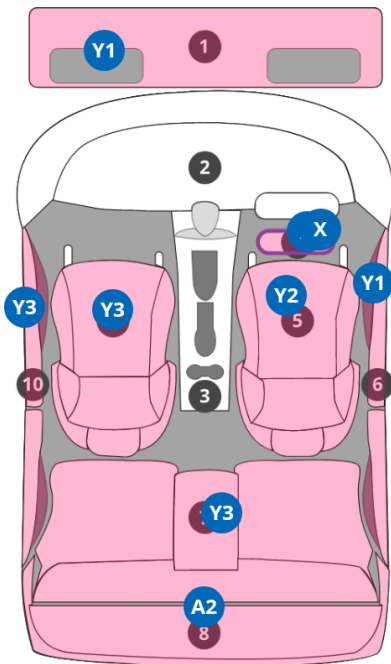
<p>a : Cut, Fray d : Loose, Deformed k : Animal Hair s : Smell t : Cigarette Burns x : Defective y : Stain</p>

<p>A : Scratch AU : Scratch & Dent B : Modified C : Corrosion G : Stone chip P : Faded S : Rust SC : Rust & Corrosion U : Dent X : Defective Y : Crack, Gap</p>
<p>Remarks (R) Front Floor Mat - Missing - Yes / (L) Front Floor Mat - Missing - Yes / Mat Other - Missing - Yes / (R) Front Seat - Grime - Small / (R) Front Trim - Grime - Minimal / Rear Seat - Grime - Medium / Trunk Room - Worn, Scratch, Cut, Crack - Small / (L) Front Seat - Grime - Medium / (L) Front Trim - Grime - Medium / Ceiling - Grime - Minimal</p>	<p>Remarks (L) Rear Fender - Repair Traces - Yes / Trunk Hood, Rear Gate - Repair Traces - Yes / (L) Rear Fender, Molding - Repair mark - Yes / (L) Mirror - Scratch - Minimal / (L) Front Fender, Molding - Scratch - Minimal / Bonnet, Headlight - Scratch - Minimal / Front Bumper, Grille, Lamps - Scratch - Small / (R) Front Fender, Molding - Scratch - Small / (R) Mirror - Scratch - Minimal / (R) Front Door, Molding - Scratch - Small / (R) Rear Door, Molding - Scratch - Medium / (R) Rear Fender, Molding - Scratch - Minimal / Trunk Hood, Rear Gate - Scratch - Minimal / Rear Bumper, Lamps, Panels - Scratch - Small / Roof - Scratch - Small / (L) Rear Fender, Molding - Scratch - Minimal</p>

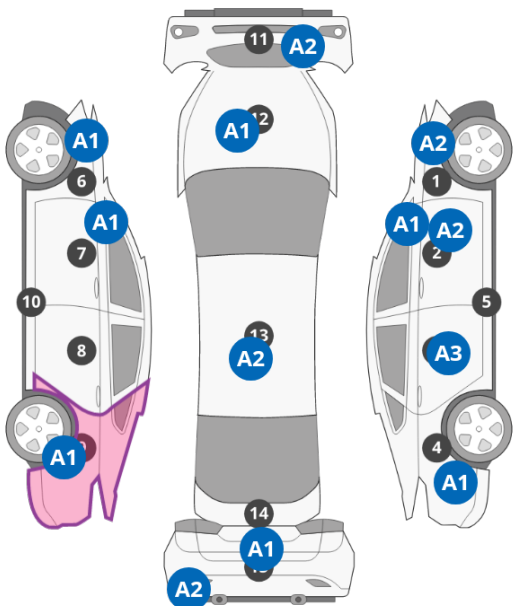
<p>Inspector Notes</p>
<p>with LTO plate/No spare key/No spare tire/No reverse camera/No fog light/No seat cover/No warranty booklet/with jack No tools/left side rear fender repainted/front and back floor mats missing/trunk room cover missing</p>
