General Information

Make	Toyota	Model	Vios
YOM	2025	Odo Meter Reading	6,018
Registration No.	NJC6891	Chassis No.	PA1B18F32S4289713
CC	1.3	Transmission	CVT
Fuel Type	Gas	Type of Body	Sedan
Colour	Blue

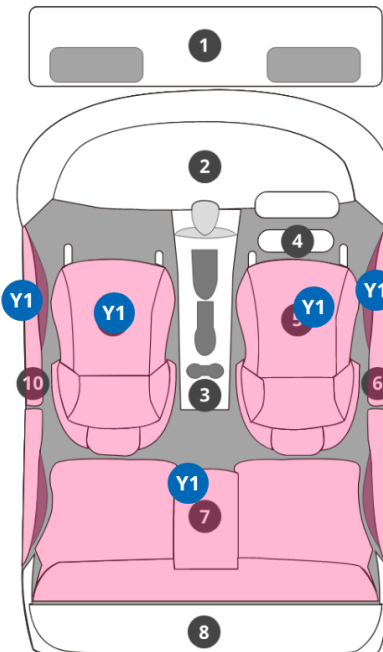
Interior Evaluation : A	Exterior Evaluation : C

<p>a : Cut, Fray d : Loose, Deformed k : Animal Hair s : Smell t : Cigarette Burns x : Defective y : Stain</p>

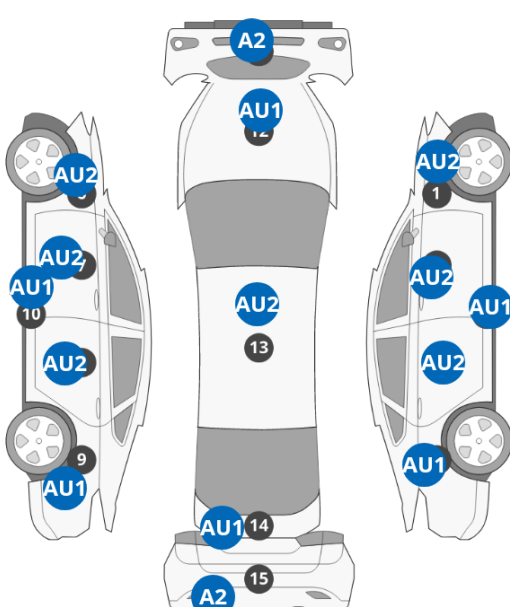
<p>A : Scratch AU : Scratch & Dent B : Modified C : Corrosion G : Stone chip P : Faded S : Rust SC : Rust & Corrosion U : Dent X : Defective Y : Crack, Gap</p>
<p>Remarks (L) Front Seat - Grime - Minimal / (R) Front Seat - Grime - Minimal / (L) Front Trim - Grime - Minimal / (R) Front Trim - Grime - Minimal / Rear Seat - Grime - Minimal</p>	<p>Remarks Roof - Scratch & Dent - Small / (L) Front Door, Molding - Scratch & Dent - Small / (L) Rear Door, Molding - Scratch & Dent - Small / (L) Front Fender, Molding - Scratch & Dent - Small / Bonnet, Headlight - Scratch & Dent - Minimal / Front Bumper, Grille, Lamps - Scratch - Small / (R) Front Fender, Molding - Scratch & Dent - Small / (R) Front Door, Molding - Scratch & Dent - Small / (R) Rear Door, Molding - Scratch & Dent - Small / (R) Rear Fender, Molding - Scratch & Dent - Minimal / Rear Bumper, Lamps, Panels - Scratch - Small / Trunk Hood, Rear Gate - Scratch & Dent - Minimal / (L) Rear Fender, Molding - Scratch & Dent - Minimal / (R) Step, In-panel, Side Spoiler - Scratch & Dent - Minimal / (L) Step, In-panel, Side Spoiler - Scratch & Dent - Minimal</p>
