General Information

Make	Toyota	Model	Vios
YOM	2025	Odo Meter Reading	17,952
Registration No.	NKH1623	Chassis No.	PA1B18F3XR4273656
CC	1.3	Transmission	CVT
Fuel Type	Gas	Type of Body	Sedan
Colour	Silver

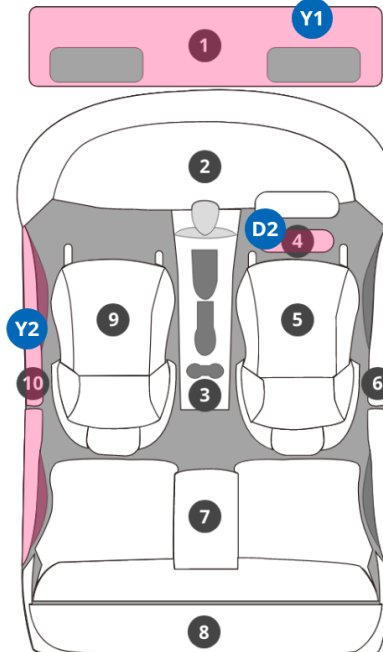
<p>a : Cut, Fray d : Loose, Deformed k : Animal Hair s : Smell t : Cigarette Burns x : Defective y : Stain</p>

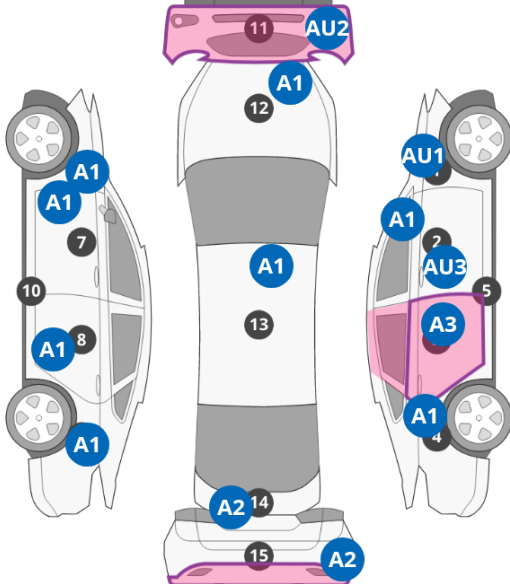
<p>A : Scratch AU : Scratch & Dent B : Modified C : Corrosion G : Stone chip P : Faded S : Rust SC : Rust & Corrosion U : Dent X : Defective Y : Crack, Gap</p>
<p>Remarks (L) Front Trim - Grime - Small / (L) Front Floor Mat - Worked - Small / Ceiling - Grime - Minimal</p>	<p>Remarks (R) Front Fender, Molding - Scratch & Dent - Minimal / (R) Mirror - Scratch - Minimal / (R) Front Door, Molding - Scratch & Dent - Medium / (R) Rear Door, Molding - Scratch - Medium / (R) Rear Door, Molding - Repair mark - Yes / Rear Bumper, Lamps, Panels - Repair mark - Yes / (R) Rear Fender, Molding - Scratch - Minimal / Rear Bumper, Lamps, Panels - Scratch - Small / Trunk Hood, Rear Gate - Scratch - Small / (L) Rear Fender, Molding - Scratch - Minimal / (L) Rear Door, Molding - Scratch - Minimal / (L) Front Door, Molding - Scratch - Minimal / (L) Front Fender, Molding - Scratch - Minimal / Front Bumper, Grille, Lamps - Repair mark - Yes / Front Bumper, Grille, Lamps - Scratch & Dent - Small / Bonnet, Headlight - Scratch - Minimal / Roof - Scratch - Minimal</p>
