General Information

Make	Toyota	Model	Vios
YOM	2025	Odo Meter Reading	16,098
Registration No.	NKL4353	Chassis No.	PA1B18F32R4281136
CC	1.3	Transmission	CVT
Fuel Type	Gas	Type of Body	Sedan
Colour	Silver

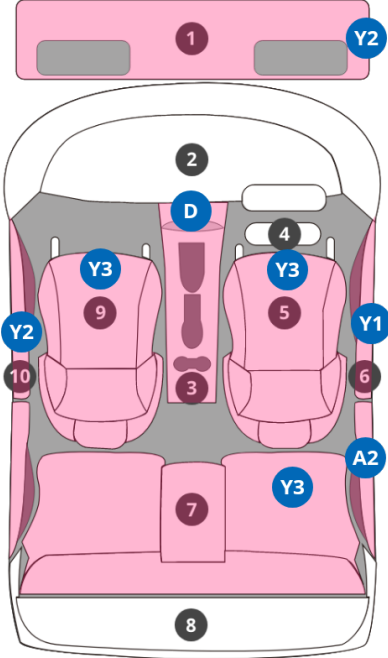
Interior Evaluation : C	Exterior Evaluation : C

<p>a : Cut, Fray d : Loose, Deformed k : Animal Hair s : Smell t : Cigarette Burns x : Defective y : Stain</p>

<p>A : Scratch AU : Scratch & Dent B : Modified C : Corrosion G : Stone chip P : Faded S : Rust SC : Rust & Corrosion U : Dent X : Defective Y : Crack, Gap</p>
<p>Remarks (R) Front Trim - Grime - Minimal / (R) Rear Trim - Cut, Crack - Small / (R) Front Seat - Grime - Medium / (L) Front Seat - Grime - Medium / Console, Switchs, Vents - Traces of Adhesive Tape - Yes / (L) Front Trim - Grime - Small / Rear Seat - Grime - Medium / Ceiling - Grime - Small</p>	<p>Remarks (L) Front Fender - Repair Traces - Yes / (L) Rear Fender - Repair Traces - Yes / (R) Rear Fender - Repair Traces - Yes / (R) Mirror - Scratch - Minimal / (R) Front Door, Molding - Scratch - Small / (R) Front Fender, Molding - Scratch - Minimal / (R) Step, In-panel, Side Spoiler - Repair mark - Yes / (R) Step, In-panel, Side Spoiler - Dent - Medium / (R) Rear Door, Molding - Scratch - Minimal / (R) Rear Fender, Molding - Scratch - Minimal / Rear Bumper, Lamps, Panels - Repair mark - Yes / Rear Bumper, Lamps, Panels - Scratch - Small / Trunk Hood, Rear Gate - Scratch - Small / (L) Rear Fender, Molding - Scratch - Minimal / (L) Rear Door, Molding - Scratch - Small / (L) Mirror - Scratch - Minimal / (L) Step, In-panel, Side Spoiler - Dent - Small / (L) Front Door, Molding - Crack, Gap - Medium / (L) Front Fender, Molding - Scratch - Minimal / Front Bumper, Grille, Lamps - Scratch - Small / Bonnet, Headlight - Scratch - Minimal / Roof - Scratch - Minimal</p>

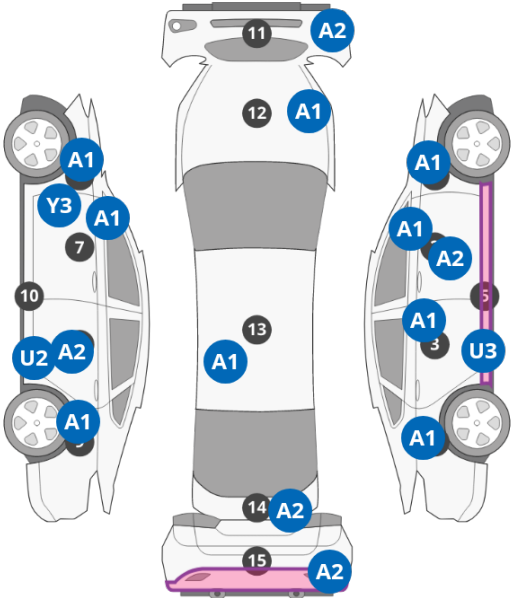
<p>Inspector Notes</p>
<p>no warranty booklet, with jack, incomplete tools, with spare tire, no LTO plate, scratches on tail light</p>
