## General Information

<b>Make</b>	Toyota	<b>Model</b>	Vios
<b>YOM</b>	2025	<b>Odo Meter Reading</b>	7,349
<b>Registration No.</b>	NKS9239	<b>Chassis No.</b>	PA1B18F31S4289377
<b>CC</b>	1.3	<b>Transmission</b>	CVT
<b>Fuel Type</b>	Gas	<b>Type of Body</b>	Sedan
<b>Colour</b>	Red Mica Metallic

## Body / Panel Condition

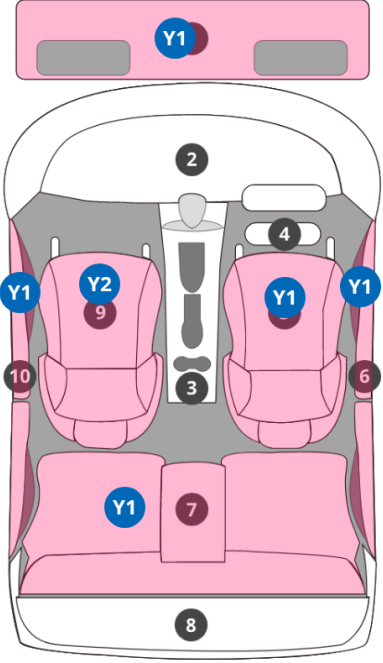
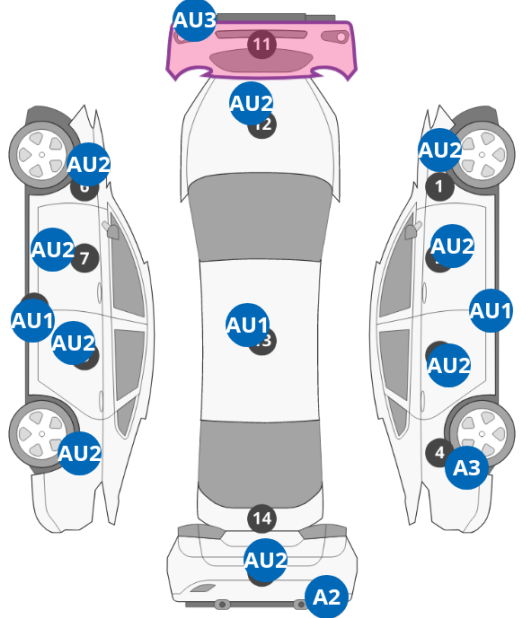
<b>Interior Evaluation :</b>	A	<b>Exterior Evaluation :</b>	D

<p><b>a</b> : Cut, Fray <b>d</b> : Loose, Deformed <b>k</b> : Animal Hair <b>s</b> : Smell <b>t</b> : Cigarette Burns <b>x</b> : Defective <b>y</b> : Stain</p>		<p><b>A</b> : Scratch <b>AU</b> : Scratch &amp; Dent <b>B</b> : Modified <b>C</b> : Corrosion <b>G</b> : Stone chip <b>P</b> : Faded <b>S</b> : Rust <b>SC</b> : Rust &amp; Corrosion <b>U</b> : Dent <b>X</b> : Defective <b>Y</b> : Crack, Gap</p>	
<p><b>Remarks</b> (L) Front Seat - Grime - Small / (R) Front Seat - Grime - Minimal / (L) Front Trim - Grime - Minimal / (R) Front Trim - Grime - Minimal / Ceiling - Grime - Minimal / Rear Seat - Grime - Minimal</p>		<p><b>Remarks</b> (R) Front Fender, Molding - Scratch &amp; Dent - Small / (R) Front Door, Molding - Scratch &amp; Dent - Small / (R) Rear Door, Molding - Scratch &amp; Dent - Small / (R) Rear Fender, Molding - Scratch - Medium / Rear Bumper, Lamps, Panels - Scratch - Small / Trunk Hood, Rear Gate - Scratch &amp; Dent - Small / (L) Rear Fender, Molding - Scratch &amp; Dent - Small / (L) Rear Door, Molding - Scratch &amp; Dent - Small / (L) Step, In-panel, Side Spoiler - Scratch &amp; Dent - Minimal / (R) Step, In-panel, Side Spoiler - Scratch &amp; Dent - Minimal / (L) Front Door, Molding - Scratch &amp; Dent - Small / Roof - Scratch &amp; Dent - Minimal / (L) Front Fender, Molding - Scratch &amp; Dent - Small / Bonnet, Headlight - Scratch &amp; Dent - Small / Front Bumper, Grille, Lamps - Repair mark - Yes / Front Bumper, Grille, Lamps - Scratch &amp; Dent - Medium</p>
