## General Information

<b>Make</b>	Toyota	<b>Model</b>	Vios
<b>YOM</b>	2010	<b>Odo Meter Reading</b>	268,767
<b>Registration No.</b>	PFQ358	<b>Chassis No.</b>	NCP938008339
<b>CC</b>	1.5	<b>Transmission</b>	M/T
<b>Fuel Type</b>	Gas	<b>Type of Body</b>	Sedan
<b>Colour</b>	Brown

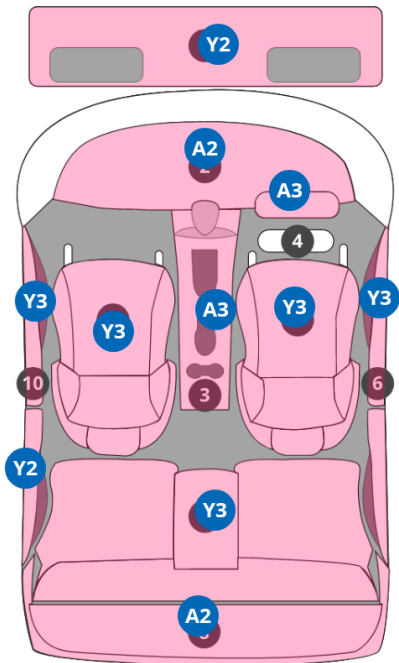
<b>Interior Evaluation :</b> <span style="float: right;"><b>D</b></span>	<b>Exterior Evaluation :</b> <span style="float: right;"><b>E</b></span>

<p><b>a</b> : Cut, Fray <b>d</b> : Loose, Deformed <b>k</b> : Animal Hair <b>s</b> : Smell <b>t</b> : Cigarette Burns <b>x</b> : Defective <b>y</b> : Stain</p>

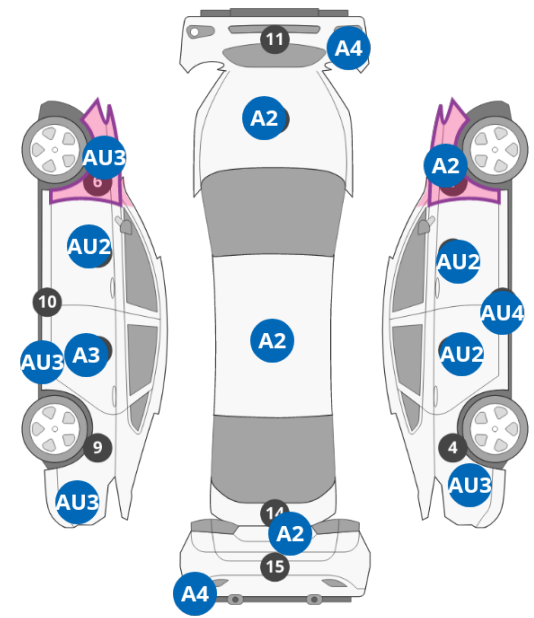
<p><b>A</b> : Scratch <b>AU</b> : Scratch &amp; Dent <b>B</b> : Modified <b>C</b> : Corrosion <b>G</b> : Stone chip <b>P</b> : Faded <b>S</b> : Rust <b>SC</b> : Rust &amp; Corrosion <b>U</b> : Dent <b>X</b> : Defective <b>Y</b> : Crack, Gap</p>
<b>Remarks</b> (R) Front Seat - Grime - Medium / (R) Front Trim - Grime - Medium / Dashboard - Worn, Scratch, Cut, Crack - Small / Console, Switches, Vents - Worn, Scratch, Cut, Crack - Medium / Rear Seat - Grime - Medium / Trunk Room - Worn, Scratch, Cut, Crack - Small / (L) Rear Trim - Grime - Small / (L) Front Trim - Grime - Medium / (L) Front Seat - Grime - Medium / Steering Wheel - Worn, Peel, Crack - Medium / Ceiling - Grime - Small	<b>Remarks</b> (R) Front Fender - Repair Traces - Yes / (L) Front Fender - Repair Traces - Yes / (L) Rear Fender, Molding - Scratch & Dent - Medium / (R) Front Fender, Molding - Repair mark - Yes / (L) Front Fender, Molding - Repair mark - Yes / Trunk Hood, Rear Gate - Scratch - Small / Rear Bumper, Lamps, Panels - Scratch - Large / (L) Rear Door, Molding - Scratch - Medium / (L) Step, In-panel, Side Spoiler - Scratch & Dent - Medium / (L) Front Door, Molding - Scratch & Dent - Small / (L) Front Fender, Molding - Scratch & Dent - Medium / Front Bumper, Grille, Lamps - Scratch - Large / Bonnet, Headlight - Scratch - Small / (R) Front Fender, Molding - Scratch - Small / (R) Front Door, Molding - Scratch & Dent - Small / (R) Step, In-panel, Side Spoiler - Scratch & Dent - Large / (R) Rear Door, Molding - Scratch & Dent - Small / (R) Rear Fender, Molding - Scratch & Dent - Medium / Roof - Scratch - Small
