## General Information

<b>Make</b>	Toyota	<b>Model</b>	Vios
<b>YOM</b>	2012	<b>Odo Meter Reading</b>	158,216
<b>Registration No.</b>	TIE680	<b>Chassis No.</b>	NCP929046508
<b>CC</b>	1.3	<b>Transmission</b>	A/T
<b>Fuel Type</b>	Gas	<b>Type of Body</b>	Sedan
<b>Colour</b>	Brown

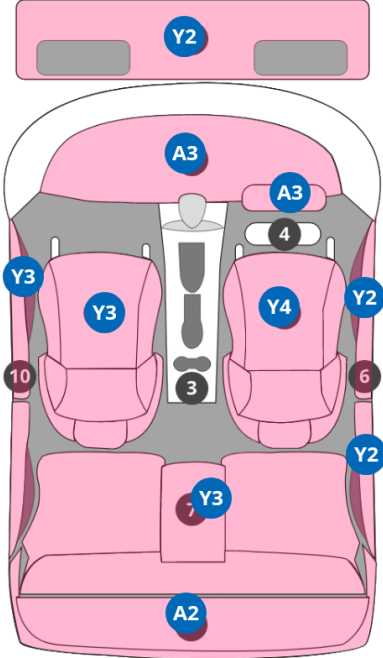
<b>Interior Evaluation :</b> <span style="float: right;"><b>D</b></span>	<b>Exterior Evaluation :</b> <span style="float: right;"><b>E</b></span>

<p><b>a</b> : Cut, Fray <b>d</b> : Loose, Deformed <b>k</b> : Animal Hair <b>s</b> : Smell <b>t</b> : Cigarette Burns <b>x</b> : Defective <b>y</b> : Stain</p>

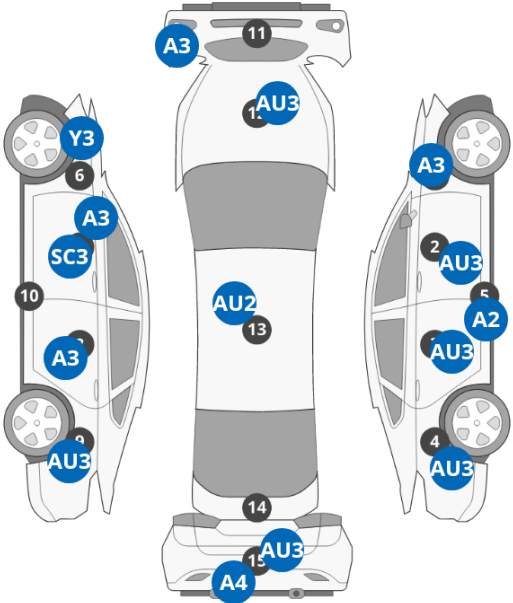
<p><b>A</b> : Scratch <b>AU</b> : Scratch &amp; Dent <b>B</b> : Modified <b>C</b> : Corrosion <b>G</b> : Stone chip <b>P</b> : Faded <b>S</b> : Rust <b>SC</b> : Rust &amp; Corrosion <b>U</b> : Dent <b>X</b> : Defective <b>Y</b> : Crack, Gap</p>
<p><b>Remarks</b> (R) Front Seat - Grime - Large / (R) Front Trim - Grime - Small / Rear Seat - Grime - Medium / (R) Rear Trim - Grime - Small / Trunk Room - Worn, Scratch, Cut, Crack - Small / (L) Front Trim - Grime - Medium / Steering Wheel - Worn, Peel, Crack - Medium / (L) Front Seat - Grime - Medium / Dashboard - Worn, Scratch, Cut, Crack - Medium / Ceiling - Grime - Small</p>	<p><b>Remarks</b> (R) Front Door - Repair Traces - Yes / (R) Front Fender - Repair Traces - Yes / Bonnet - Repair Traces - Yes / (L) Front Fender - Repair Traces - Yes / (L) Front Door - Repair Traces - Yes / (L) Rear Door - Repair Traces - Yes / (L) Rear Fender - Repair Traces - Yes / Trunk Hood, Rear Gate - Repair Traces - Yes / (R) Rear Fender - Repair Traces - Yes / (R) Rear Door - Repair Traces - Yes / Roof - Repair Traces - Yes / (R) Front Fender, Molding - Scratch - Medium / Bonnet, Headlight - Scratch &amp; Dent - Medium / Front Bumper, Grille, Lamps - Scratch - Medium / (L) Front Fender, Molding - Crack, Gap - Medium / (L) Mirror - Scratch - Medium / (L) Front Door, Molding - Rust, Corrosion - Medium / (L) Rear Door, Molding - Scratch - Medium / (L) Rear Fender, Molding - Scratch &amp; Dent - Medium / Trunk Hood, Rear Gate - Scratch &amp; Dent - Medium / Rear Bumper, Lamps, Panels - Scratch - Large / (R) Rear Fender, Molding - Scratch &amp; Dent - Medium / (R) Rear Door, Molding - Scratch &amp; Dent - Medium / (R) Step, In-panel, Side Spoiler - Scratch - Small / (R) Front Door, Molding - Scratch &amp; Dent - Medium / Roof - Scratch &amp; Dent - Small</p>
