## General Information

<b>Make</b>	Toyota	<b>Model</b>	Vios
<b>YOM</b>	2011	<b>Odo Meter Reading</b>	164,688
<b>Registration No.</b>	VFF105 - NON-MOVING	<b>Chassis No.</b>	NCP929038665
<b>CC</b>	1.3	<b>Transmission</b>	M/T
<b>Fuel Type</b>	Gas	<b>Type of Body</b>	Sedan
<b>Colour</b>	Black

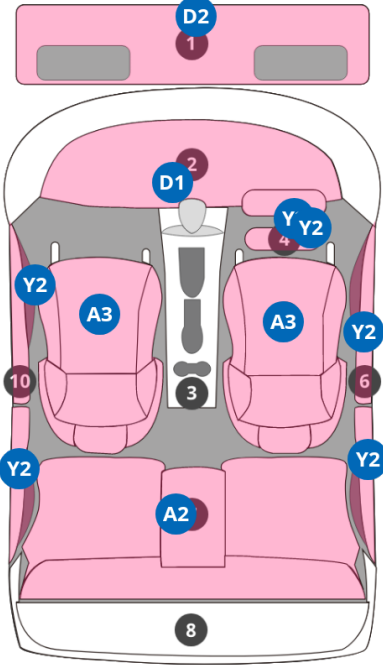
<p><b>a</b> : Cut, Fray <b>d</b> : Loose, Deformed <b>k</b> : Animal Hair <b>s</b> : Smell <b>t</b> : Cigarette Burns <b>x</b> : Defective <b>y</b> : Stain</p>

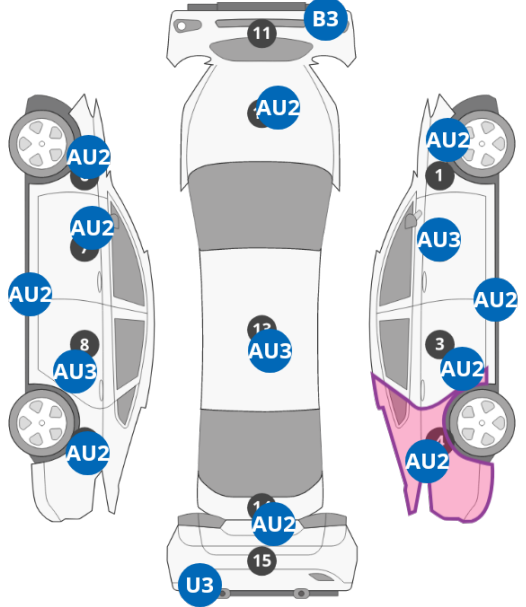
<p><b>A</b> : Scratch <b>AU</b> : Scratch &amp; Dent <b>B</b> : Modified <b>C</b> : Corrosion <b>G</b> : Stone chip <b>P</b> : Faded <b>S</b> : Rust <b>SC</b> : Rust &amp; Corrosion <b>U</b> : Dent <b>X</b> : Defective <b>Y</b> : Crack, Gap</p>
<b>Remarks</b> (L) Front Seat - Cut, Crack - Medium / (R) Front Seat - Cut, Crack - Medium / Rear Seat - Cut, Crack - Small / (L) Front Trim - Grime - Small / (R) Front Trim - Grime - Small / (L) Rear Trim - Grime - Small / (R) Rear Trim - Grime - Small / Ceiling - Crinkle - Small / Dashboard - Worked - Minimal / (R) Front Floor Mat - Grime - Small / (L) Front Floor Mat - Grime - Small	<b>Remarks</b> (R) Front Fender - Repair Traces - Yes / Bonnet - Repair Traces - Yes / (L) Front Fender - Repair Traces - Yes / (L) Front Fender, Molding - Scratch & Dent - Small / (L) Front Door, Molding - Scratch & Dent - Small / (L) Step, In-panel, Side Spoiler - Scratch & Dent - Small / (L) Rear Door, Molding - Scratch & Dent - Medium / (L) Rear Fender, Molding - Scratch & Dent - Small / Bonnet, Headlight - Scratch & Dent - Small / Overall Exterior - Faded(Color, Gloss) - Yes / (R) Front Fender, Molding - Scratch & Dent - Small / Front Bumper, Grille, Lamps - Modified - Medium / (R) Front Door, Molding - Scratch & Dent - Medium / (R) Rear Door, Molding - Scratch & Dent - Small / (R) Step, In-panel, Side Spoiler - Scratch & Dent - Small / Roof - Scratch & Dent - Medium / Trunk Hood, Rear Gate - Scratch & Dent - Small / Rear Bumper, Lamps, Panels - Dent - Medium / (R) Rear Fender, Molding - Scratch & Dent - Small / (R) Rear Fender, Molding - Repair mark - Yes
