## General Information

| Make | Toyota | Model | Vios |
| YOM | 2022 | Mileage | 48,371 |
| Registration No. | DAR7306 | Chassis No. | PA1B18F3XN4185958 |

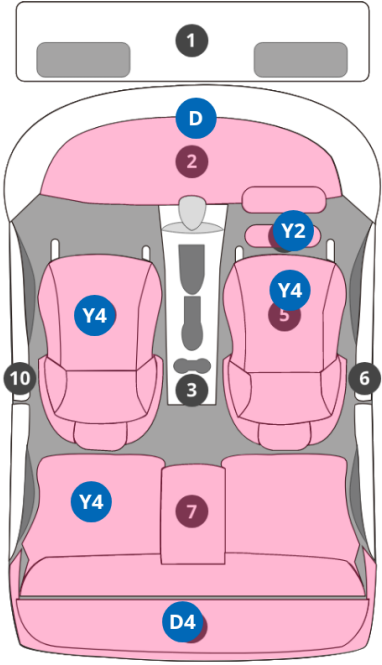
| Interior Evaluation : <span style="color: red;">C</span> | Exterior Evaluation : <span style="color: red;">E</span> |
|---|---|
| <b>Remarks</b><br>Dashboard - Traces of Adhesive Tape - Yes / (L) Front Floor Mat - Grime - Small / (R) Front Seat - Grime - Large / (L) Front Seat - Grime - Large / Rear Seat - Grime - Large / Trunk Room - Worked - Large | <b>Remarks</b><br>Trunk Hood, Rear Gate - Dent - Small / Rear Bumper, Lamps, Panels - Scratch - Large / (R) Step, In-panel, Side Spoiler - Dent - Large / (R) Front Door, Molding - Scratch & Dent - Large / (R) Front Fender, Molding - Scratch - Medium / Front Bumper, Grille, Lamps - Scratch & Dent - Medium / (L) Front Fender, Molding - Dent - Large / (L) Rear Fender, Molding - Scratch & Dent - Medium / Roof - Dent - Small / (R) Rear Door, Molding - Dent - Large |
