General Information

Make	Toyota	Model	Innova
YOM	2005	Odo Meter Reading	151,269
Registration No.	ZBF832 - NON-MOVING	Chassis No.	KUN405005196
CC	2.5	Transmission	M/T
Fuel Type	Diesel	Type of Body	Wagon
Colour	Silver

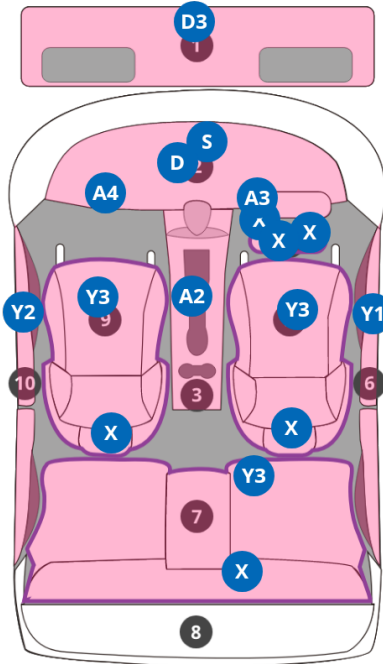
Interior Evaluation : D	Exterior Evaluation : D

<p>a : Cut, Fray d : Loose, Deformed k : Animal Hair s : Smell t : Cigarette Burns x : Defective y : Stain</p>

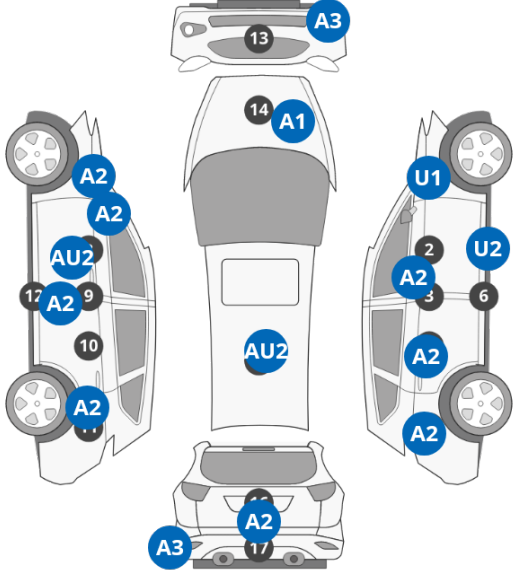
<p>A : Scratch AU : Scratch & Dent B : Modified C : Corrosion G : Stone chip P : Faded S : Rust SC : Rust & Corrosion U : Dent X : Defective Y : Crack, Gap</p>
<p>Remarks Overall Interior - Worn as per age - Yes / Overall Interior - Smell - Yes / (L) Front Floor Mat - Missing - Yes / (R) Front Floor Mat - Missing - Yes / Mat Other - Missing - Yes / Ceiling - Crinkle - Medium / (R) Front Seat - Grime - Medium / (L) Front Seat - Grime - Medium / Rear Seat - Grime - Medium / Rear Seat Head Rest - Missing - Yes / (R) Front Seat Head Rest - Missing - Yes / (L) Front Seat Head Rest - Missing - Yes / Dashboard - Traces of Adhesive Tape - Yes / Glove Box - Worn, Scratch, Cut, Crack - Medium / Knobs - Worn, Peel, Crack - Small / (R) Front Trim - Grime - Minimal / (L) Front Trim - Grime - Small / Steering Wheel - Worn, Peel, Crack - Large</p>	<p>Remarks (R) Front Door - Repair Traces - Yes / (R) Front Fender - Repair Traces - Yes / Bonnet - Repair Traces - Yes / (L) Front Fender - Repair Traces - Yes / (L) Front Door - Repair Traces - Yes / (L) Rear Door - Repair Traces - Yes / (L) Rear Fender - Repair Traces - Yes / Trunk Hood, Rear Gate - Repair Traces - Yes / (R) Rear Fender - Repair Traces - Yes / (R) Rear Door - Repair Traces - Yes / Roof - Repair Traces - Yes / Overall Exterior - Full Re-Paint in same color - Yes / Overall Exterior - Worn as per age - Yes / Overall Exterior - Faded(Color, Gloss) - Yes / (R) Front Fender, Molding - Dent - Minimal / (R) Front Door, Molding - Scratch - Small / (R) Rear Door, Molding - Scratch - Small / (R) Rear Fender, Molding - Scratch - Small / (R) Step, In-panel, Side Spoiler - Dent - Small / Rear Bumper, Lamps, Panels - Scratch - Medium / Trunk Hood, Rear Gate - Scratch - Small / (L) Rear Fender, Molding - Scratch - Small / (L) Rear Door, Molding - Scratch - Small / (L) Front Door, Molding - Scratch & Dent - Small / (L) Front Fender, Molding - Scratch - Small / (L) Mirror - Scratch - Small / Front Bumper, Grille, Lamps - Scratch - Medium / Bonnet, Headlight - Scratch - Minimal / Roof - Scratch & Dent - Small</p>
