General Information

Make	Toyota	Model	Rush
YOM	2021	Odo Meter Reading	53,692
Registration No.	EAF7160	Chassis No.	MHKE8FF3PLK025636
CC	1.5	Transmission	A/T
Fuel Type	Gas	Type of Body	Wagon
Colour	Brown

Body / Panel Condition

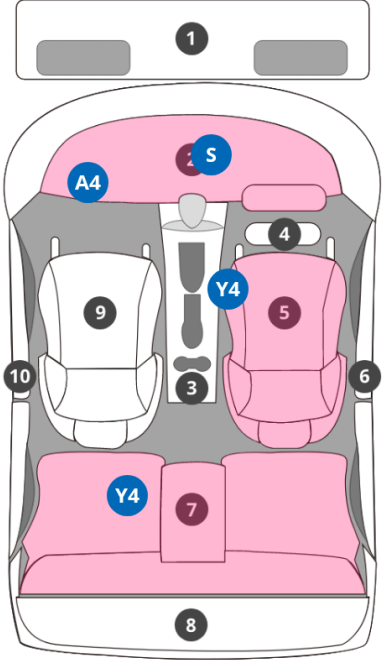
Interior Evaluation : C	Exterior Evaluation : E

<p>a : Cut, Fray d : Loose, Deformed k : Animal Hair s : Smell t : Cigarette Burns x : Defective y : Stain</p>

<p>A : Scratch AU : Scratch & Dent B : Modified C : Corrosion G : Stone chip P : Faded S : Rust SC : Rust & Corrosion U : Dent X : Defective Y : Crack, Gap</p>
<p>Remarks Steering Wheel - Worn, Peel, Crack - Large / Rear Seat - Grime - Large / (R) Front Seat - Grime - Large / Overall Interior - Smell - Yes</p>	<p>Remarks Front Bumper, Grille, Lamps - Scratch - Large / (L) Front Fender, Molding - Crack, Gap - Medium / (L) Step, In-panel, Side Spoiler - Scratch - Medium / (L) Rear Fender, Molding - Scratch & Dent - Small / (L) Front Door, Molding - Scratch - Small / Rear Bumper, Lamps, Panels - Repair mark - Yes / Trunk Hood, Rear Gate - Repair mark - Yes / Rear Bumper, Lamps, Panels - Scratch & Dent - Medium / (R) Rear Door, Molding - Scratch - Large / (R) Front Door, Molding - Scratch - Large / (R) Front Fender, Molding - Scratch - Minimal / (R) Rear Fender, Molding - Scratch - Minimal</p>
