General Information

Make	Toyota	Model	Vios
YOM	2022	Odo Meter Reading	49,059
Registration No.	DAQ1953	Chassis No.	PA1B18F30N4173348
CC	1.3	Transmission	CVT
Fuel Type	Gas	Type of Body	Sedan
Colour	Green

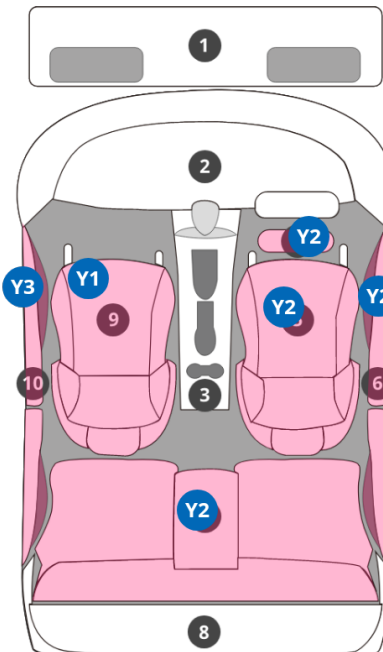
Interior Evaluation : B	Exterior Evaluation : E

<p>a : Cut, Fray d : Loose, Deformed k : Animal Hair s : Smell t : Cigarette Burns x : Defective y : Stain</p>

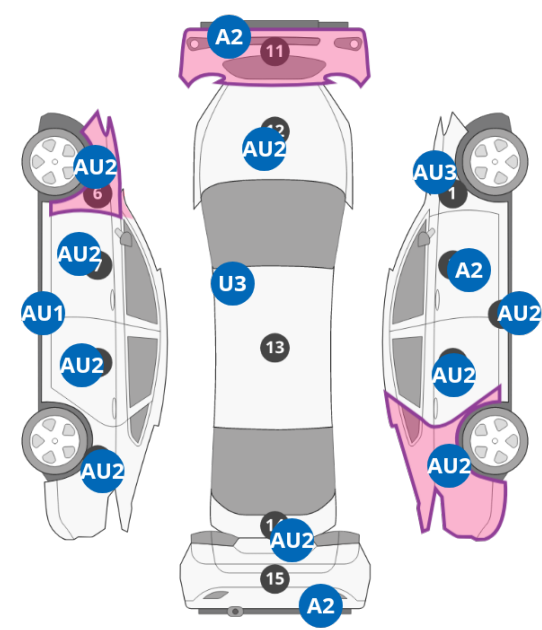
<p>A : Scratch AU : Scratch & Dent B : Modified C : Corrosion G : Stone chip P : Faded S : Rust SC : Rust & Corrosion U : Dent X : Defective Y : Crack, Gap</p>
Remarks (L) Front Seat - Grime - Minimal / (L) Front Trim - Grime - Medium / (R) Front Seat - Grime - Small / (R) Front Floor Mat - Grime - Small / Rear Seat - Grime - Small / (R) Front Trim - Grime - Small	Remarks Roof - Dent - Medium / (L) Front Door, Molding - Scratch & Dent - Small / (L) Rear Door, Molding - Scratch & Dent - Small / (L) Step, In-panel, Side Spoiler - Scratch & Dent - Minimal / (R) Step, In-panel, Side Spoiler - Scratch & Dent - Small / (R) Rear Door, Molding - Scratch & Dent - Small / (R) Front Door, Molding - Scratch - Small / (R) Rear Fender, Molding - Repair mark - Yes / (R) Rear Fender, Molding - Scratch & Dent - Small / Trunk Hood, Rear Gate - Scratch & Dent - Small / Rear Bumper, Lamps, Panels - Scratch - Small / (L) Rear Fender, Molding - Scratch & Dent - Small / Bonnet, Headlight - Scratch & Dent - Small / Front Bumper, Grille, Lamps - Scratch - Small / Front Bumper, Grille, Lamps - Repair mark - Yes / (L) Front Fender, Molding - Repair mark - Yes / (L) Front Fender, Molding - Scratch & Dent - Small / (R) Front Fender, Molding - Scratch & Dent - Medium
