## General Information

| Make | Toyota | Model | Vios |
| Registration No. | NEL2378 | Chassis No. | PA1B18F30M4143197 |

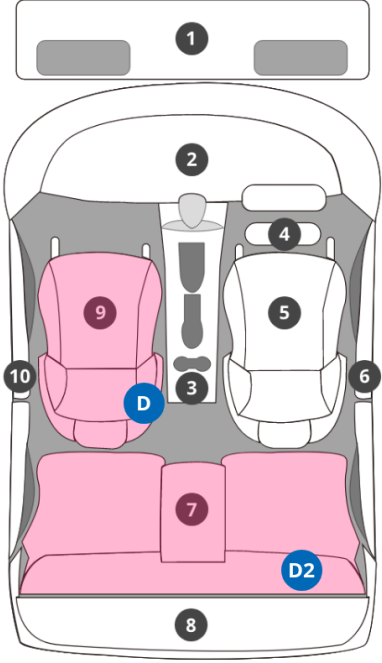
| <b>Interior Evaluation :</b> <b>B</b> | <b>Exterior Evaluation :</b> <b>B</b> |
| <b>Remarks</b><br>Rear Seat Head Rest - Worked - Small / (L) Front Seat - Worn - Yes | <b>Remarks</b><br>(L) Rear Door - Repair Traces - Yes / (R) Rear Fender, Molding - Dent - Small / Roof - Dent - Small / Rear Bumper, Lamps, Panels - Scratch - Small / Bonnet, Headlight - Dent - Small / Front Bumper, Grille, Lamps - Scratch - Small / (R) Front Fender, Molding - Scratch - Small / (R) Rear Door, Molding - Dent - Minimal / (R) Front Door, Molding - Dent - Minimal / (L) Front Door, Molding - Dent - Minimal / (L) Mirror - Scratch - Minimal |
